SMCWPPP CII Stormwater Inspector Training - Case Studies Group Exercise

June 13, 2024

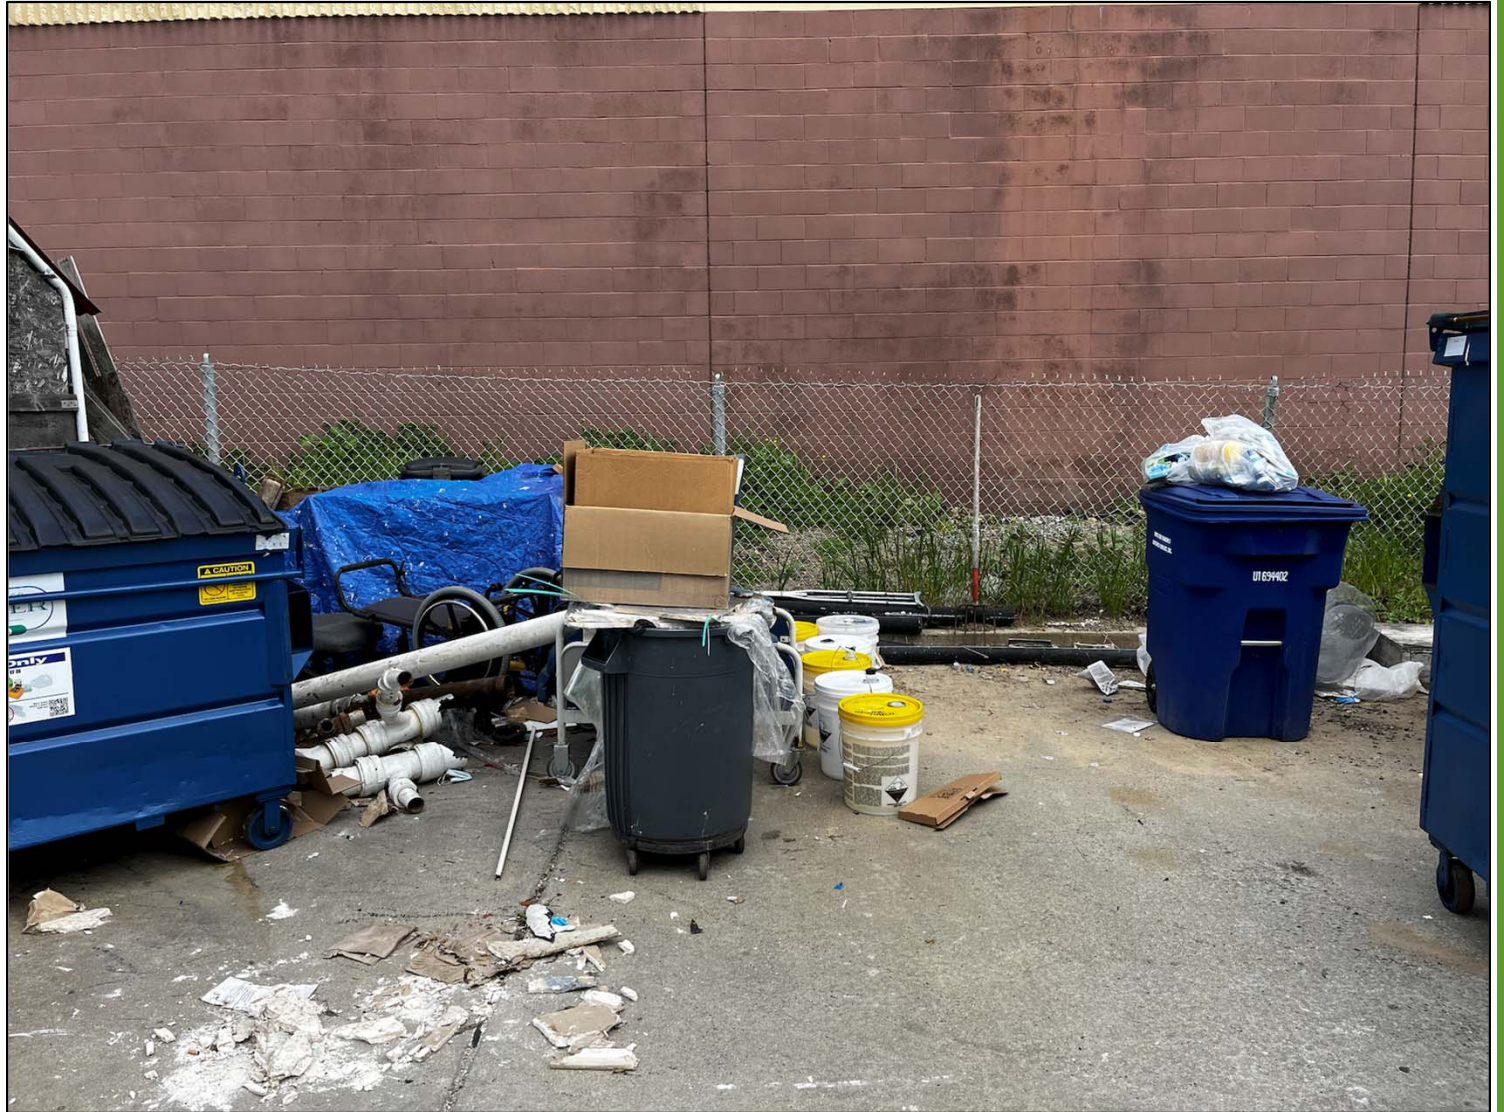
Case Study #1 - Waste Storage

Trash and debris placed near waste containers but not overflowing

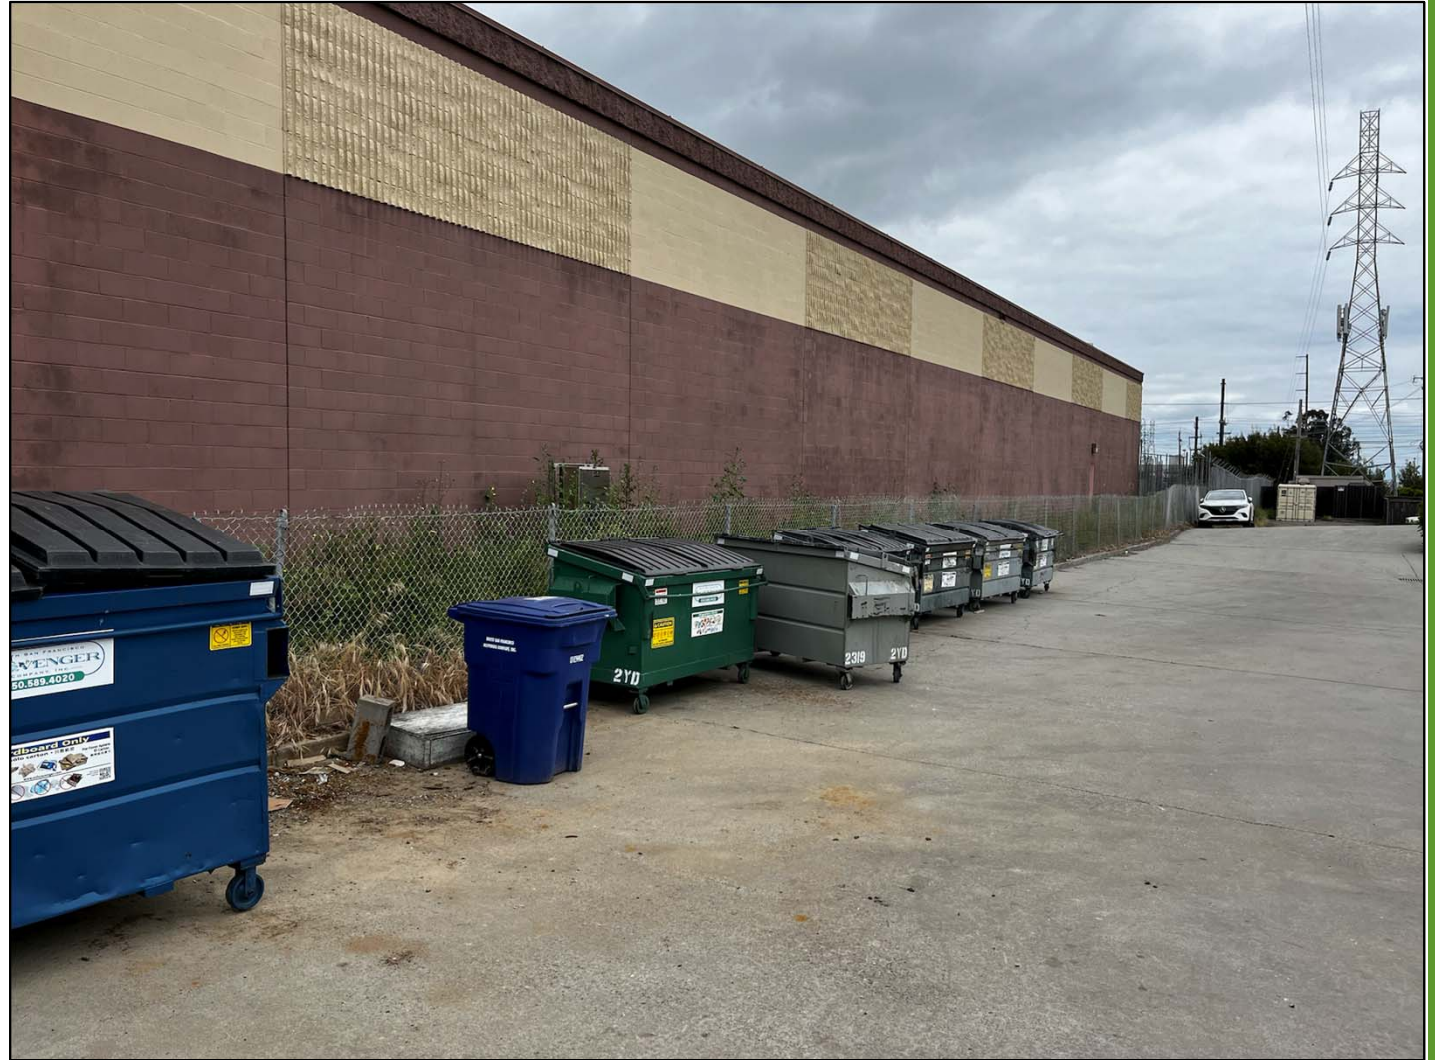
Case Study #1 - Waste Storage

Trash and debris has been cleaned and waste the containers remain lidded

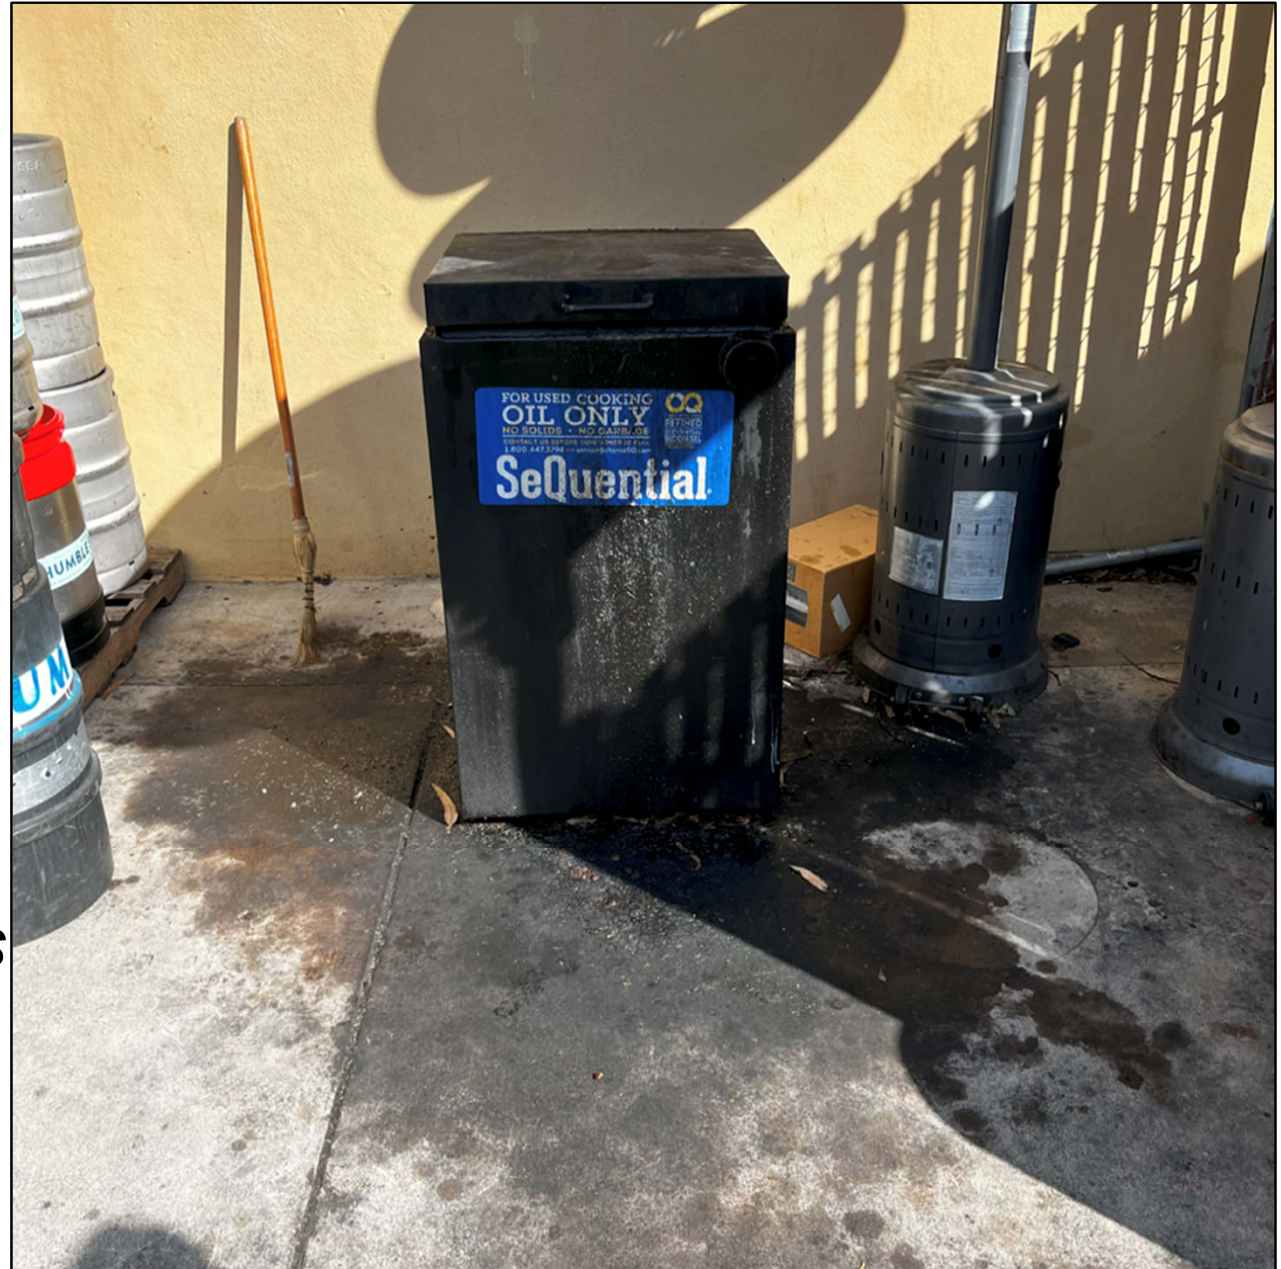
Case Study #2 - FOG Storage

FOG residue on the tallow bin and immediate area

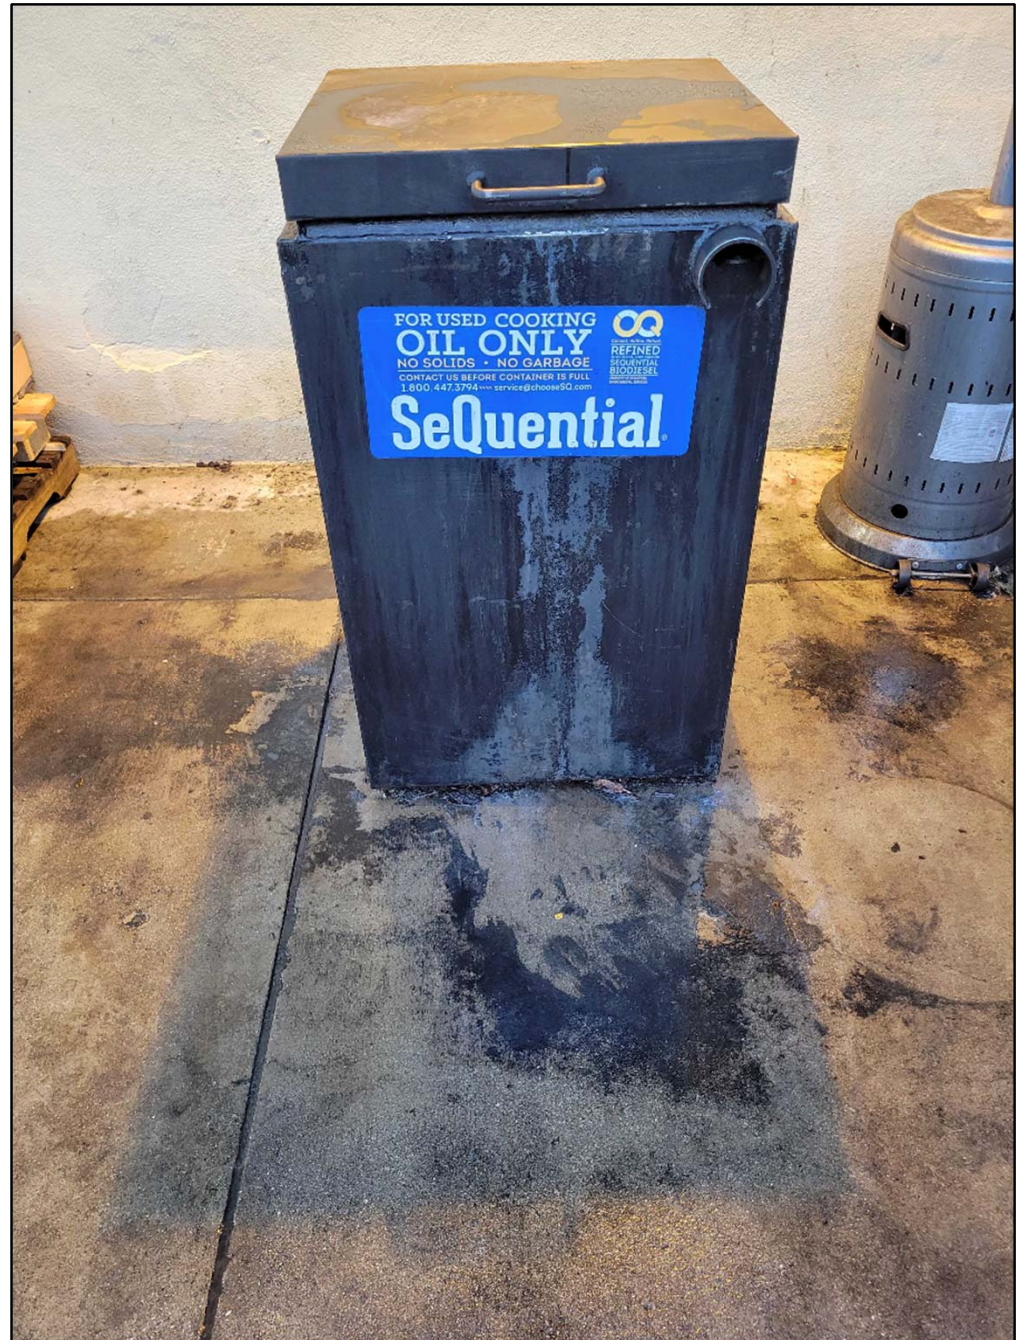
Case Study #2 - FOG Storage

Cleaned tallow bin
and immediate area

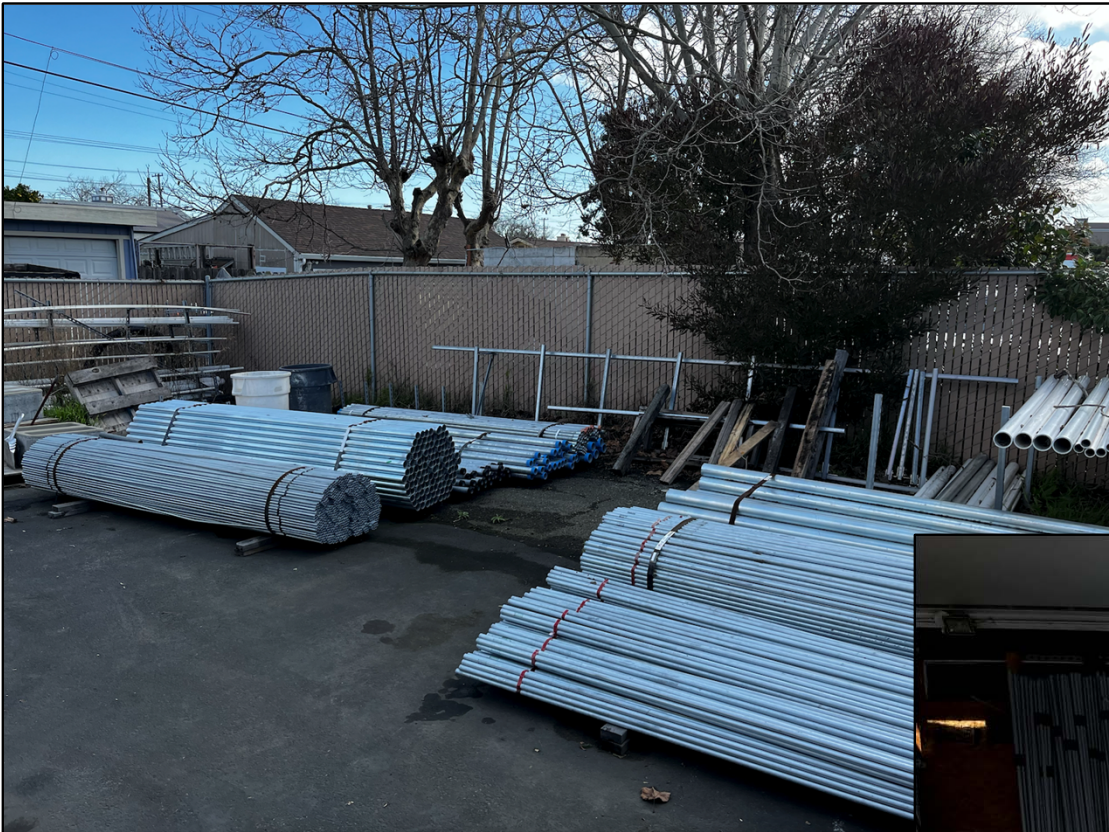
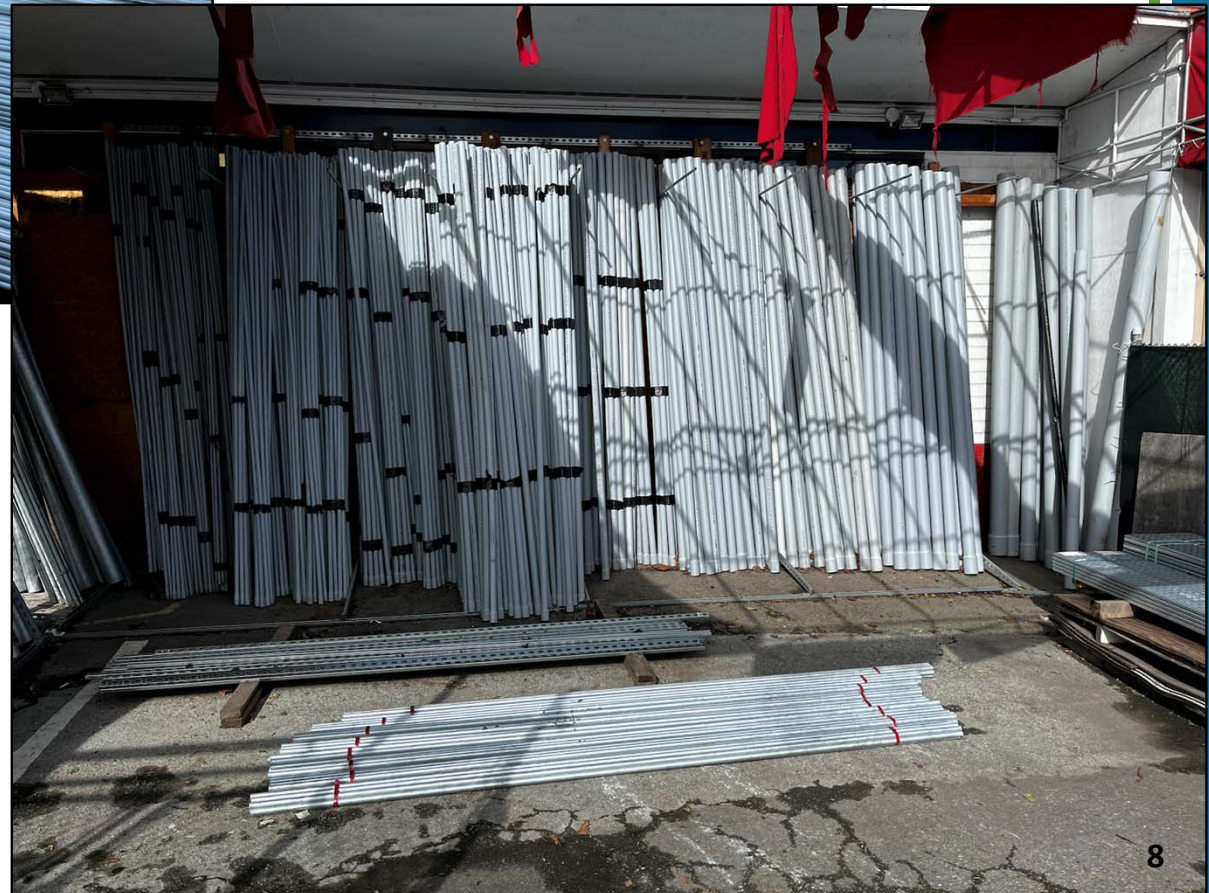
Case Study #3 - Material Storage

This facility is relatively clean and organized

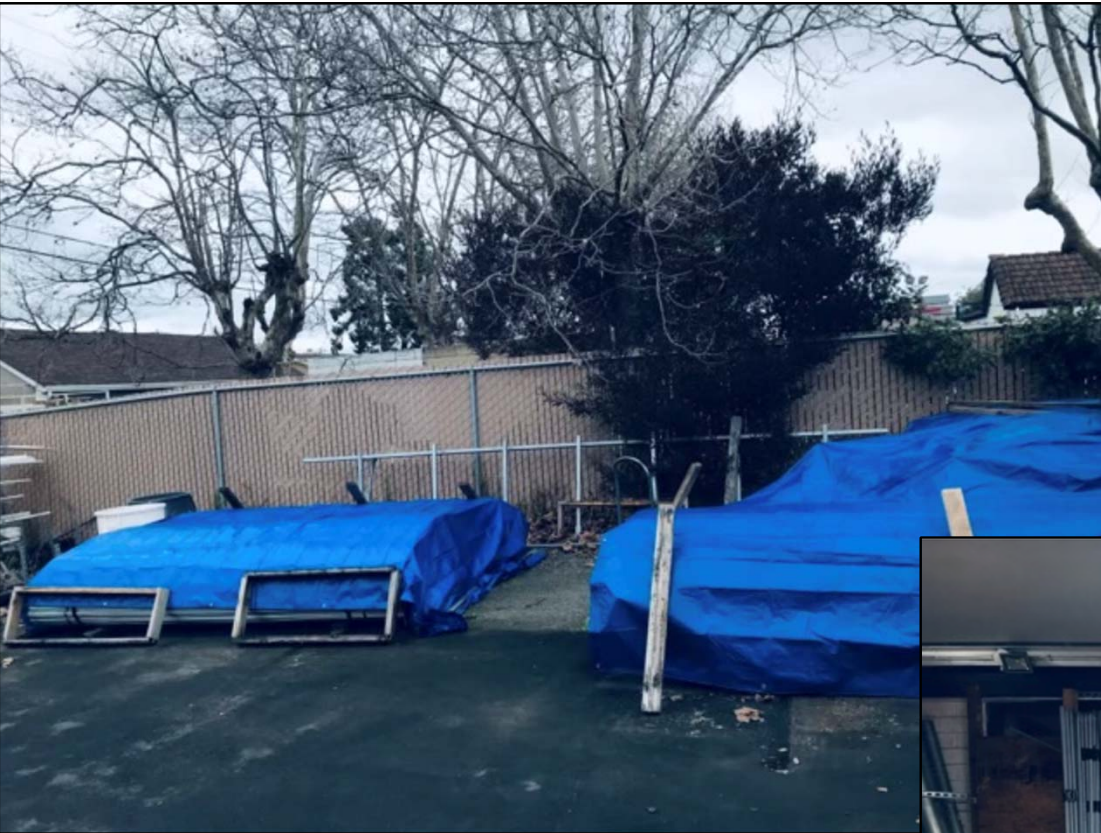
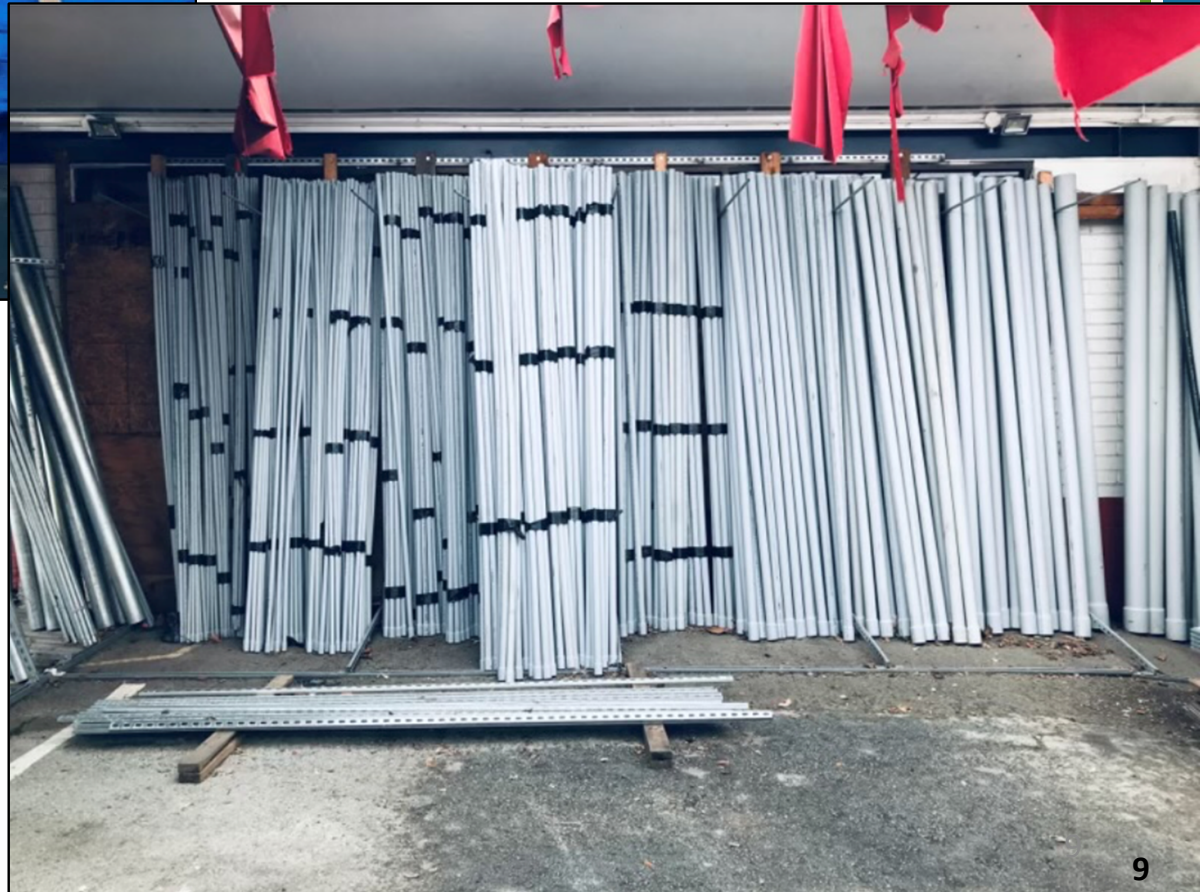
Case Study #3 - Material Storage

Galvanized material covered with tarps

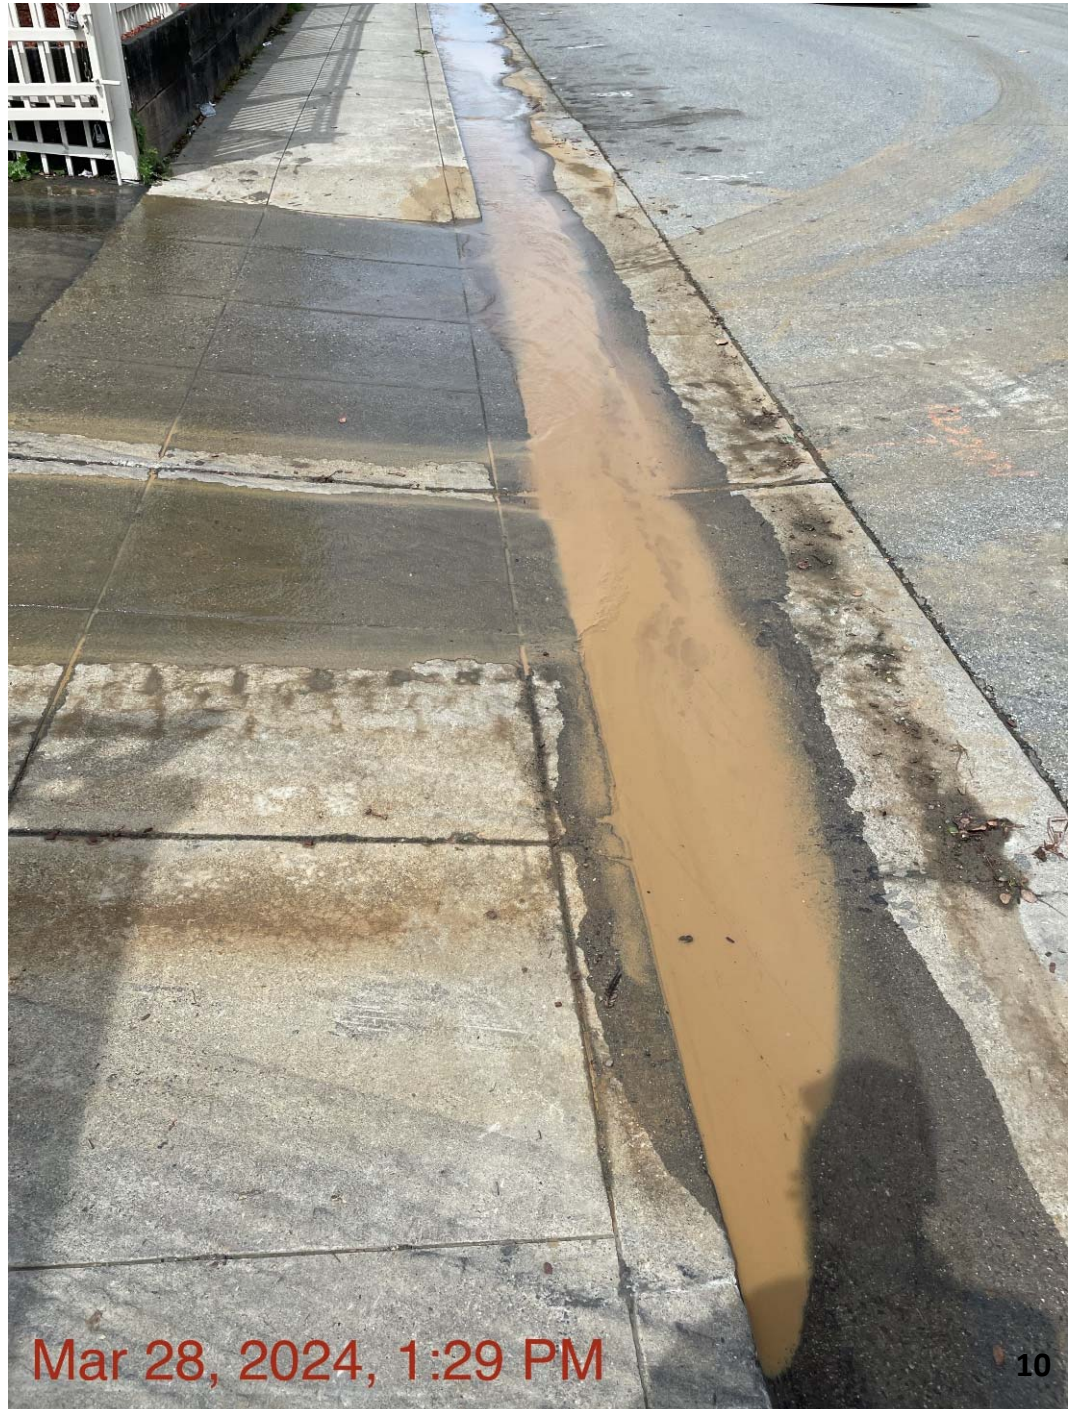
Case Study #4 - Illicit Discharge

- Muddy water from holes being drilled at construction project on school grounds
- Entered storm drain
- *Enforcement/corrective actions needed?*
- *Is this tracked in your IDDE Program or Construction Inspection Program?*

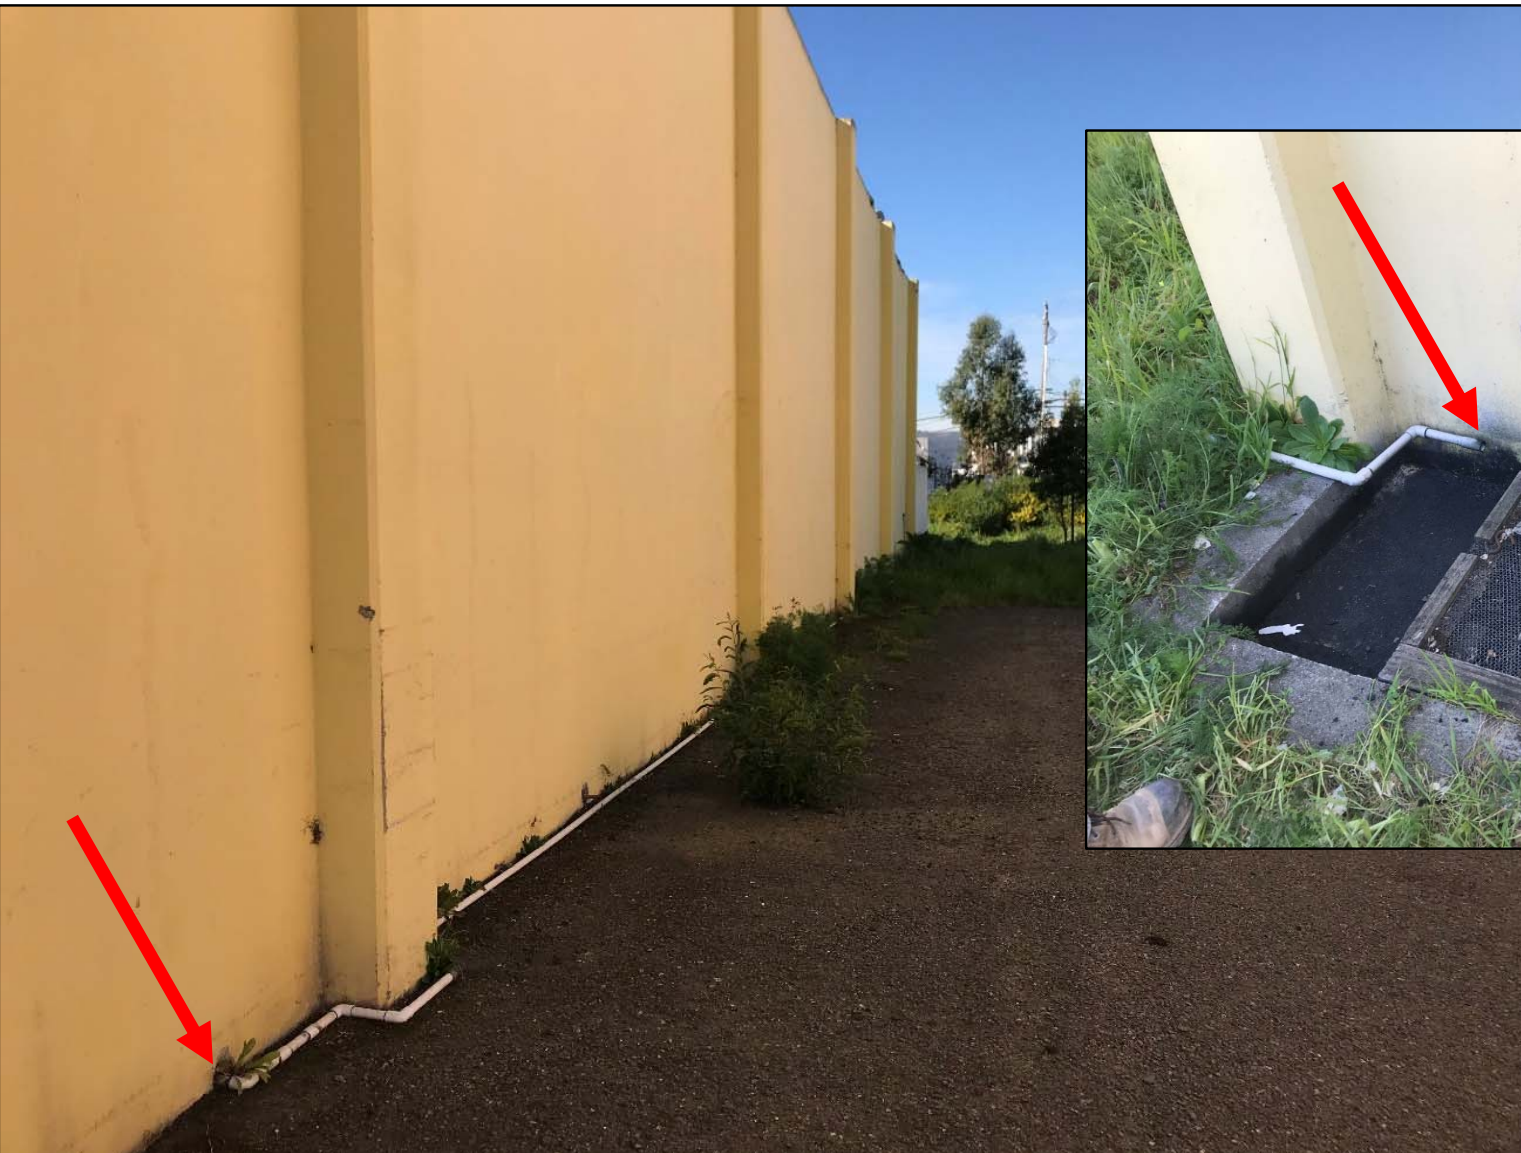
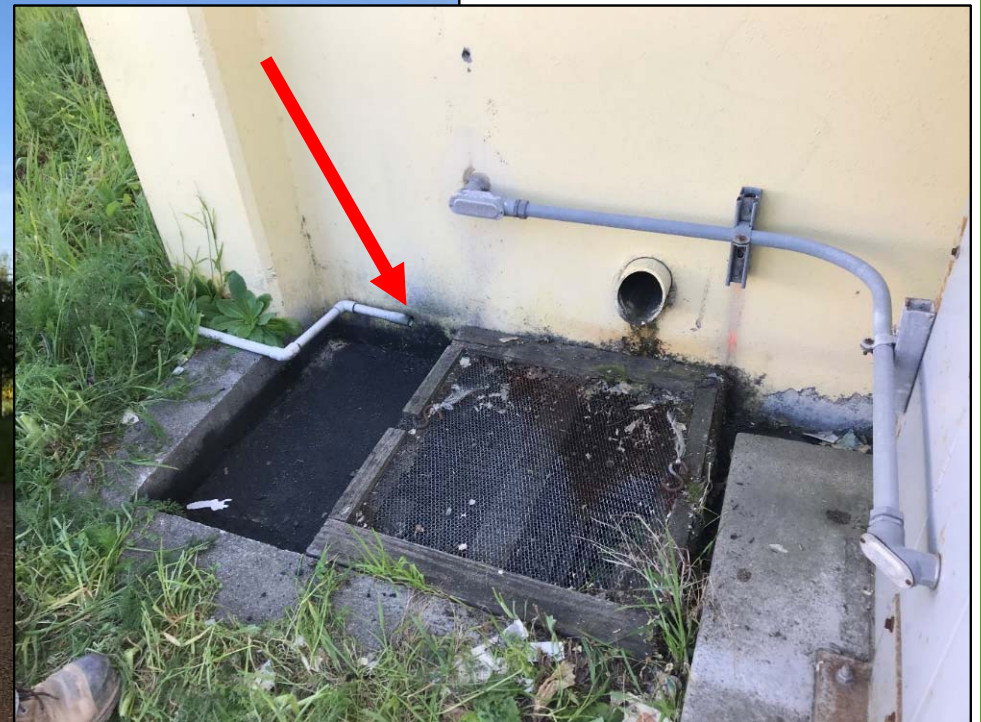
Case Study #5 – Illicit Connection

Newspaper processor has PVC pipe extending out from the building daylighting over storm drain

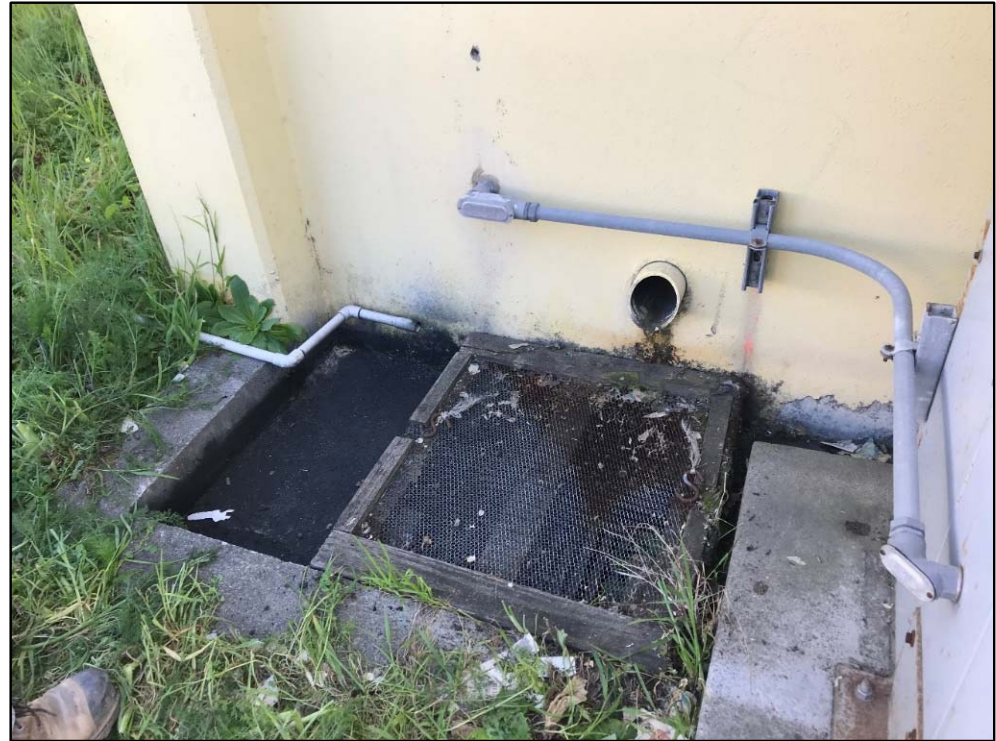
Case Study #5 – Illicit Connection

No discharge observed during the inspection
