# C.3.h Group Exercise

# Inspection Form Review

# Scenario #1 – Installation Inspection

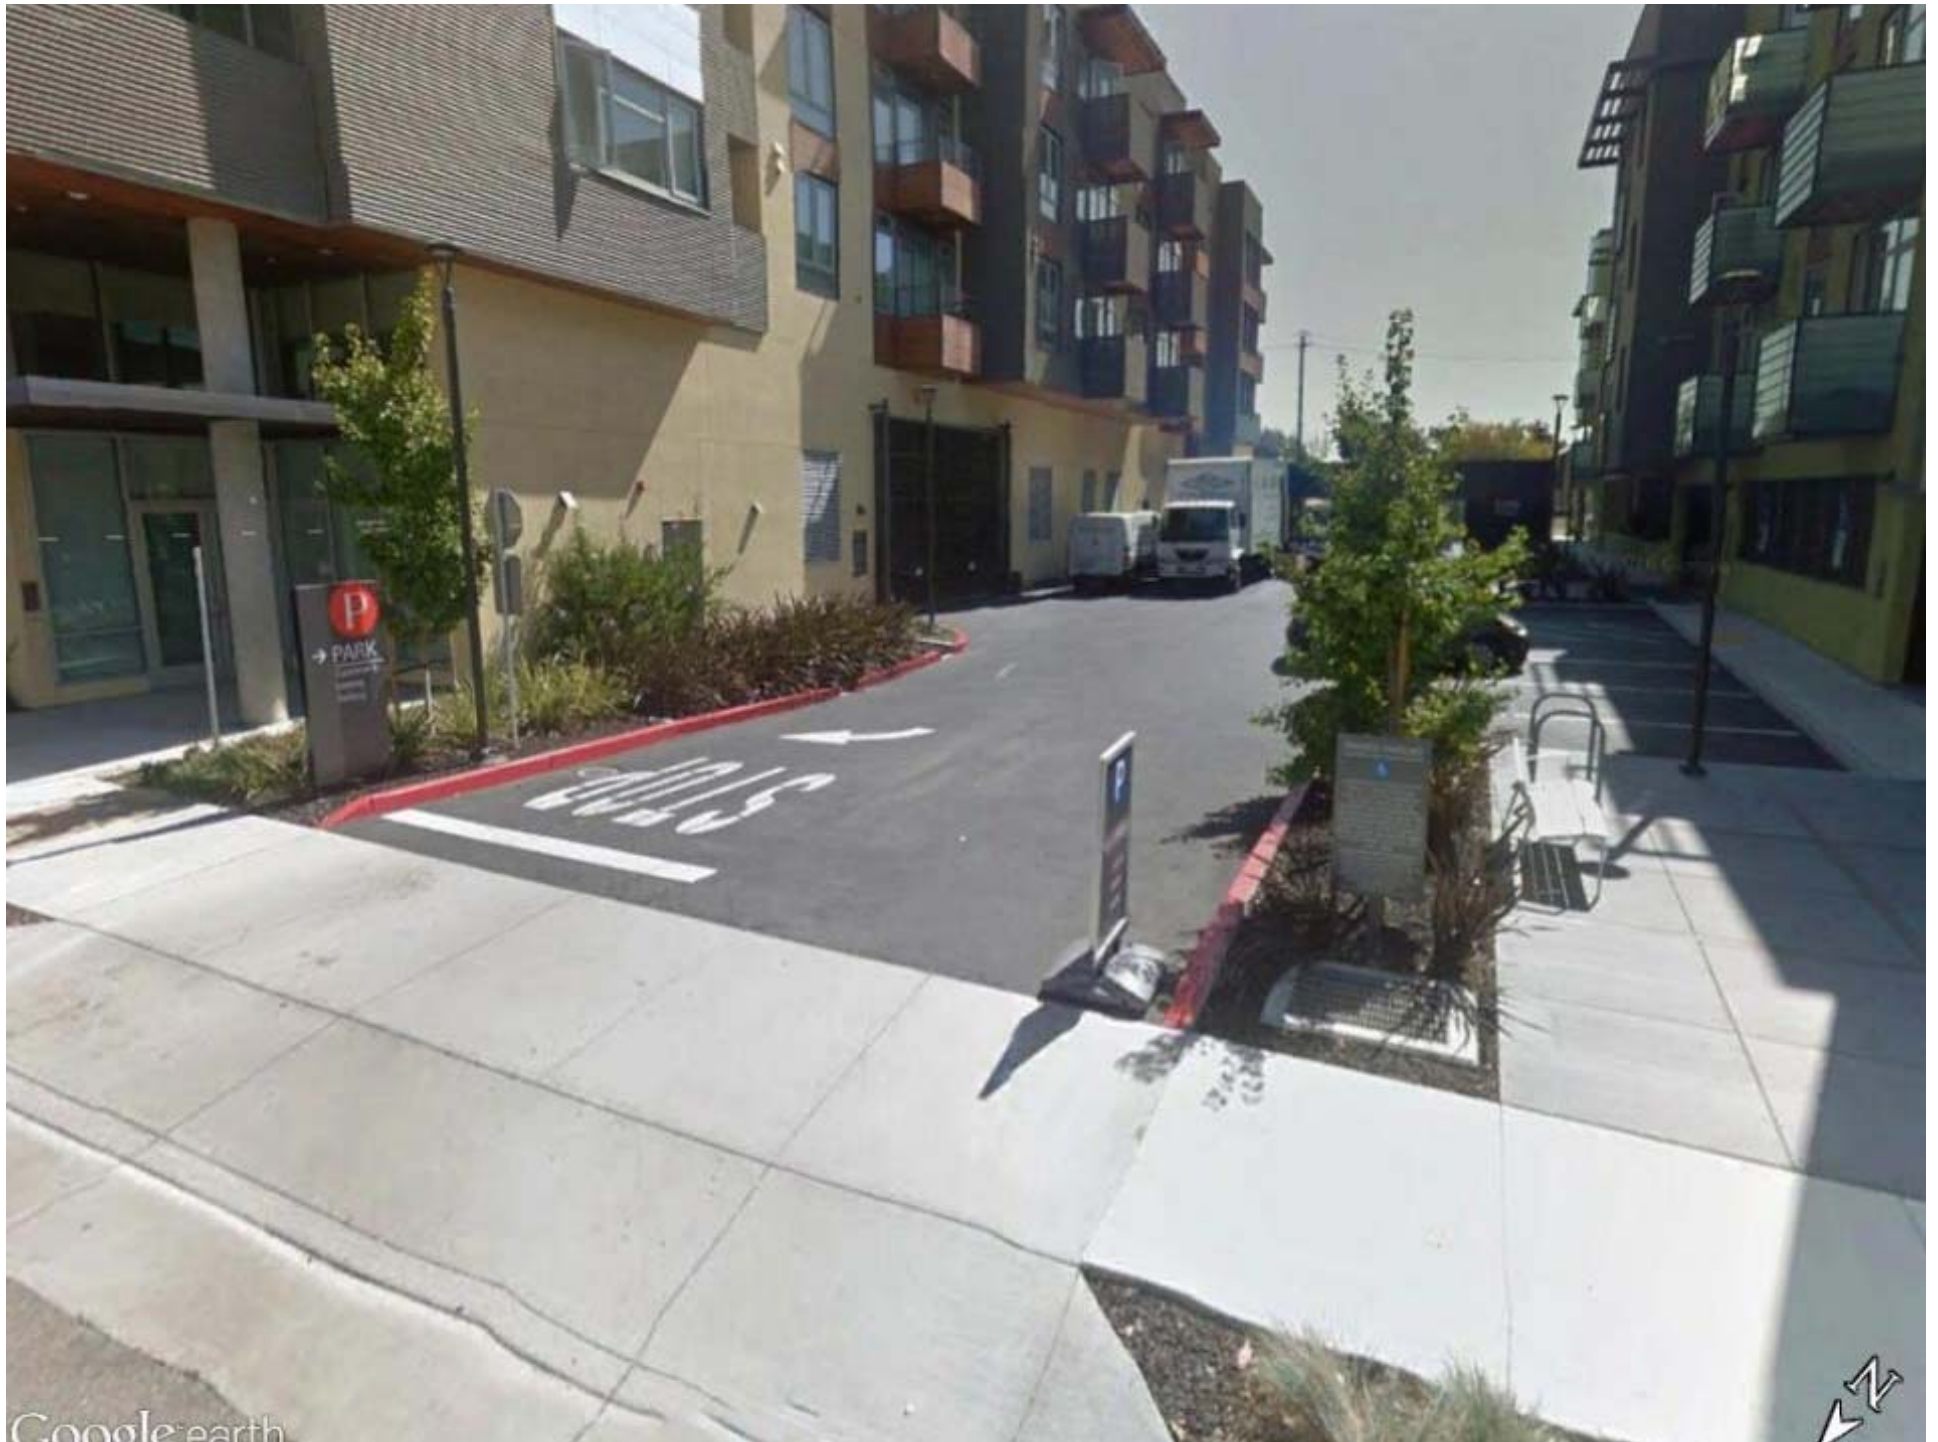
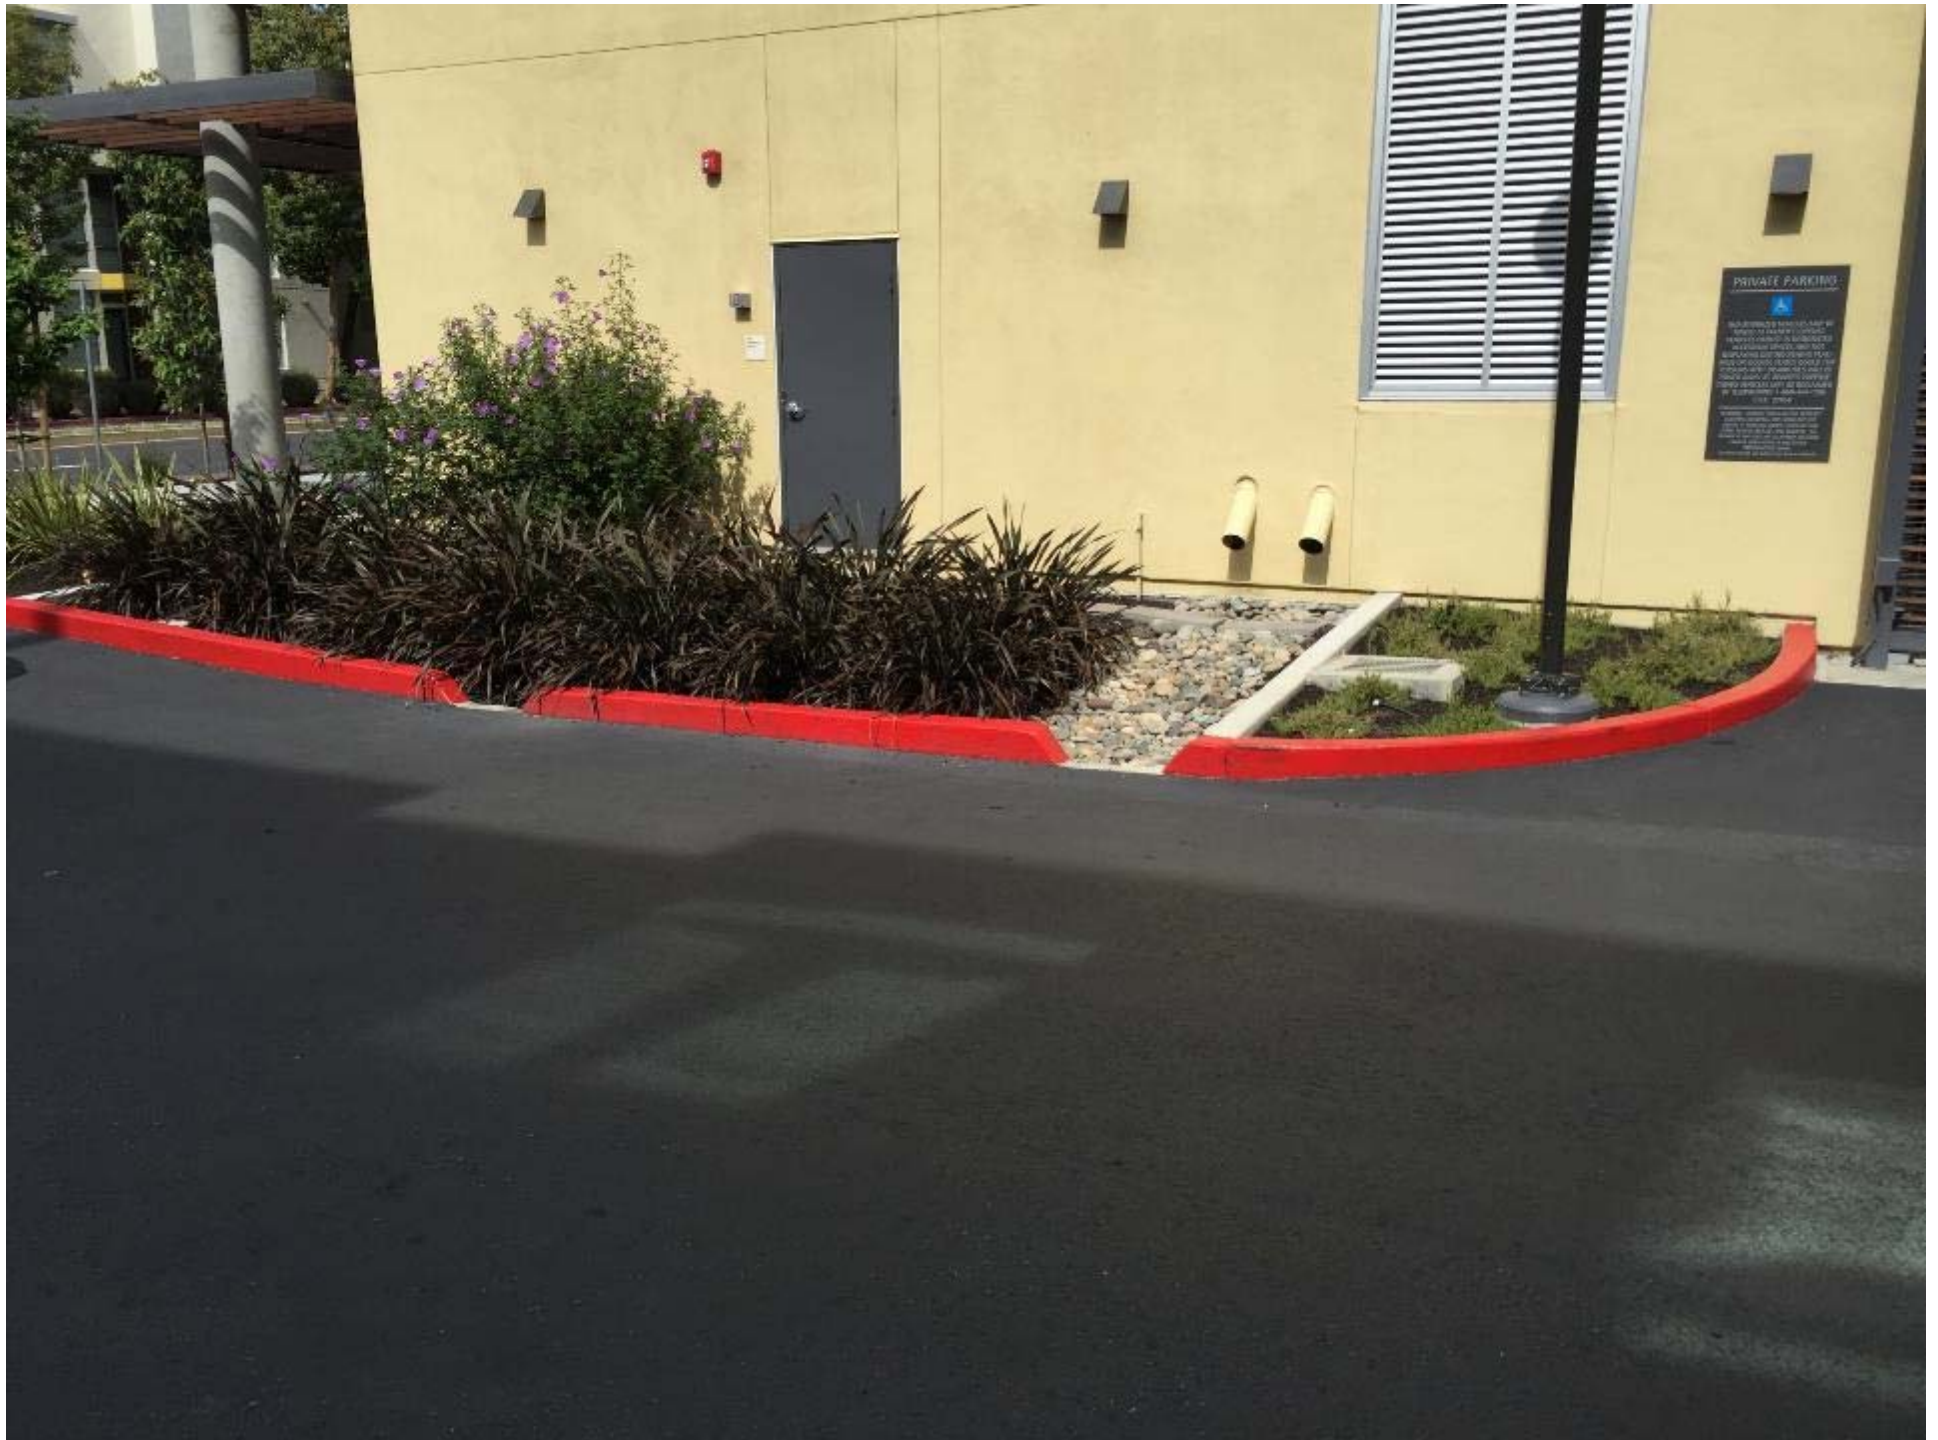
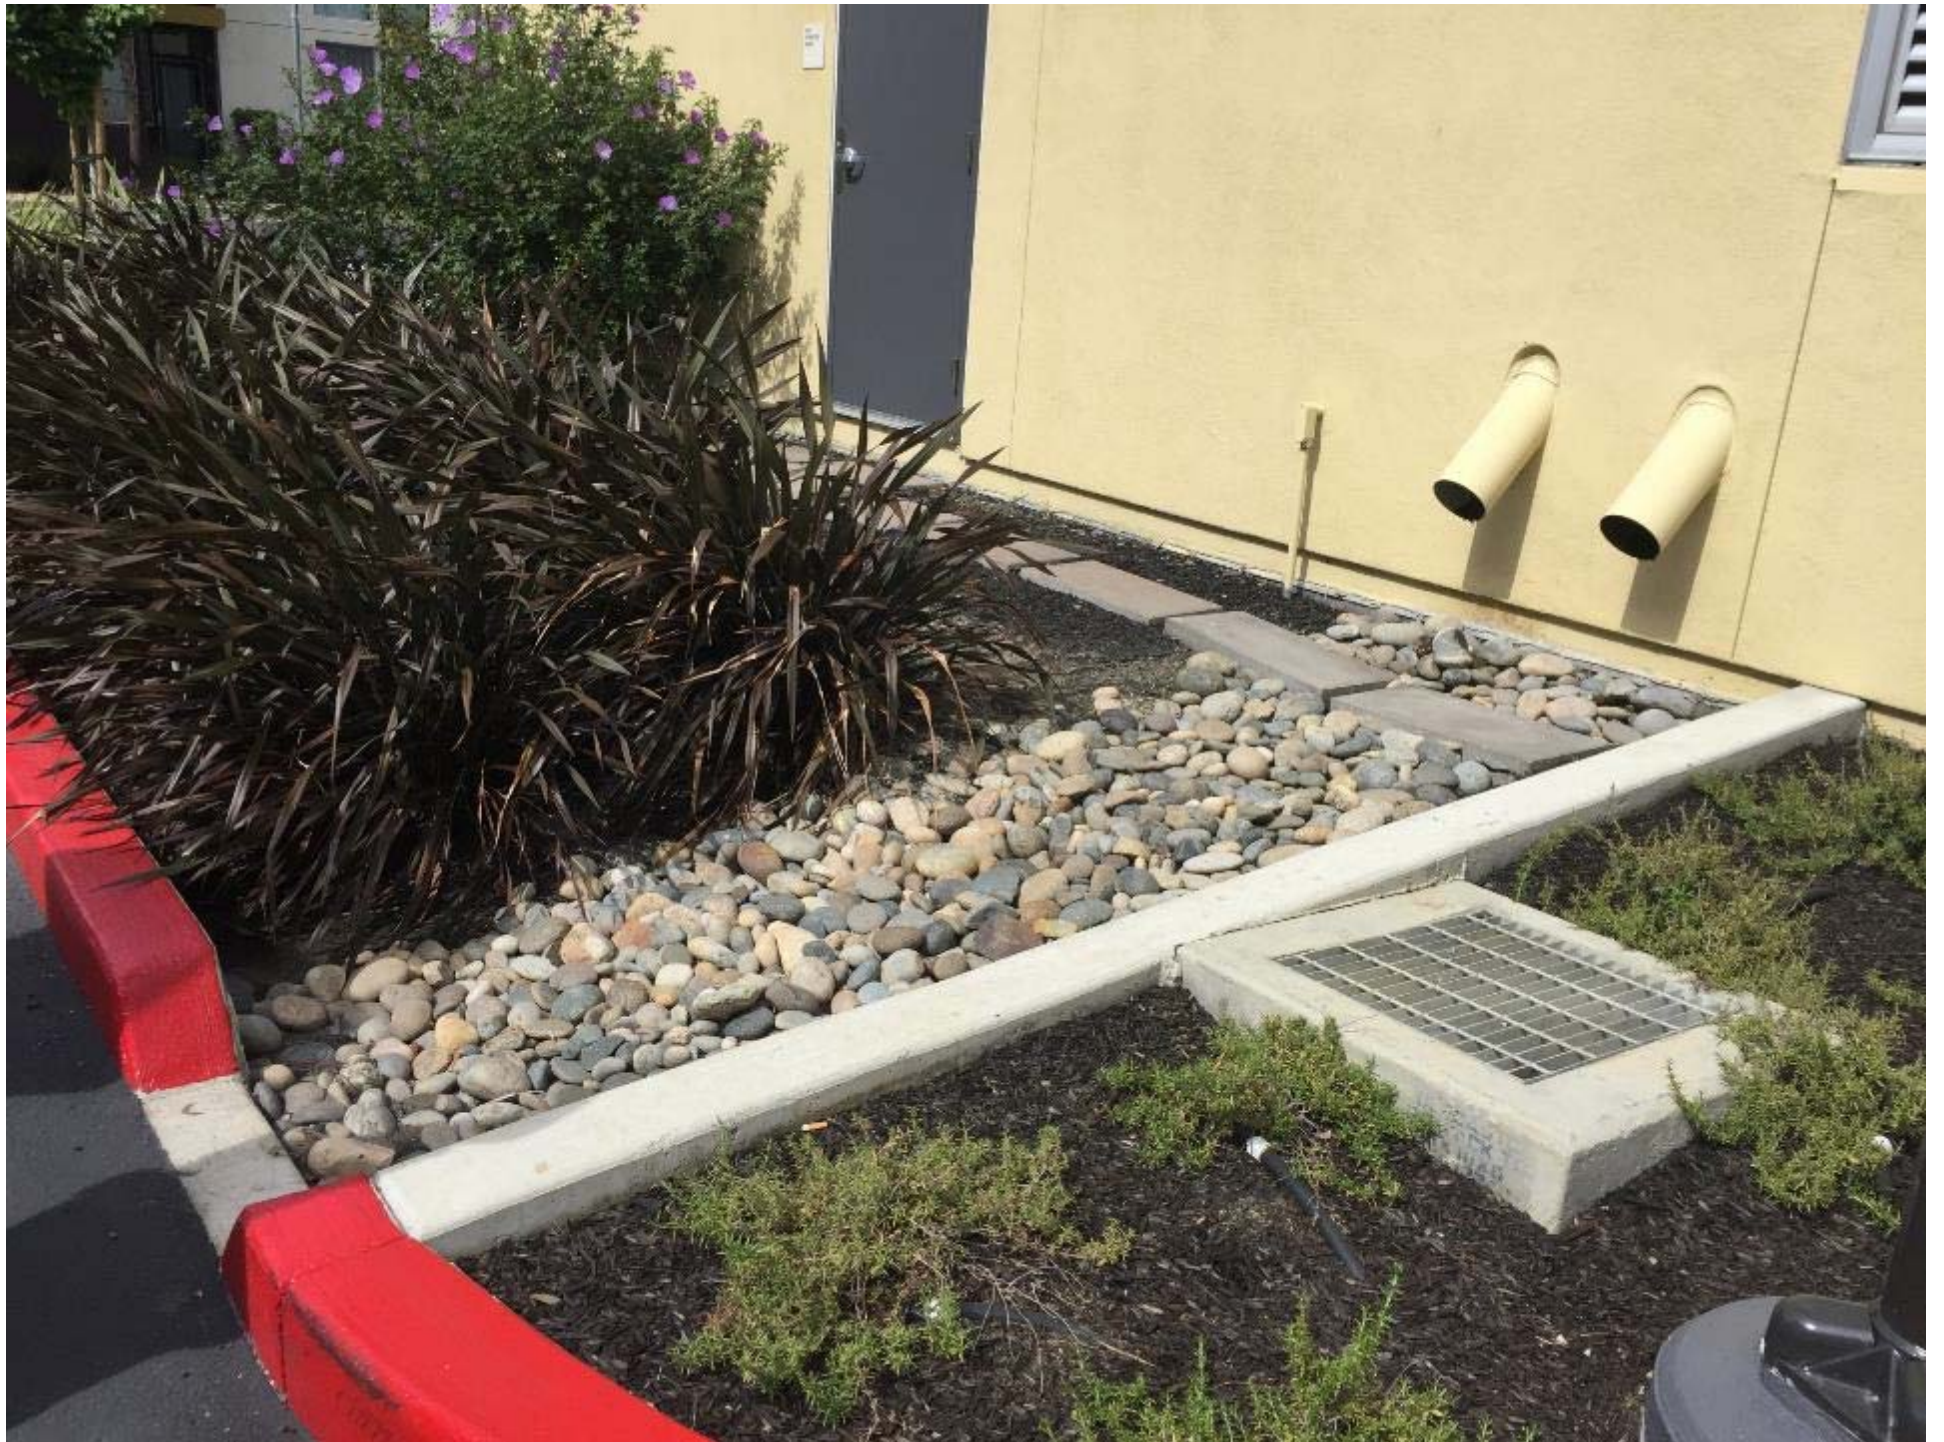
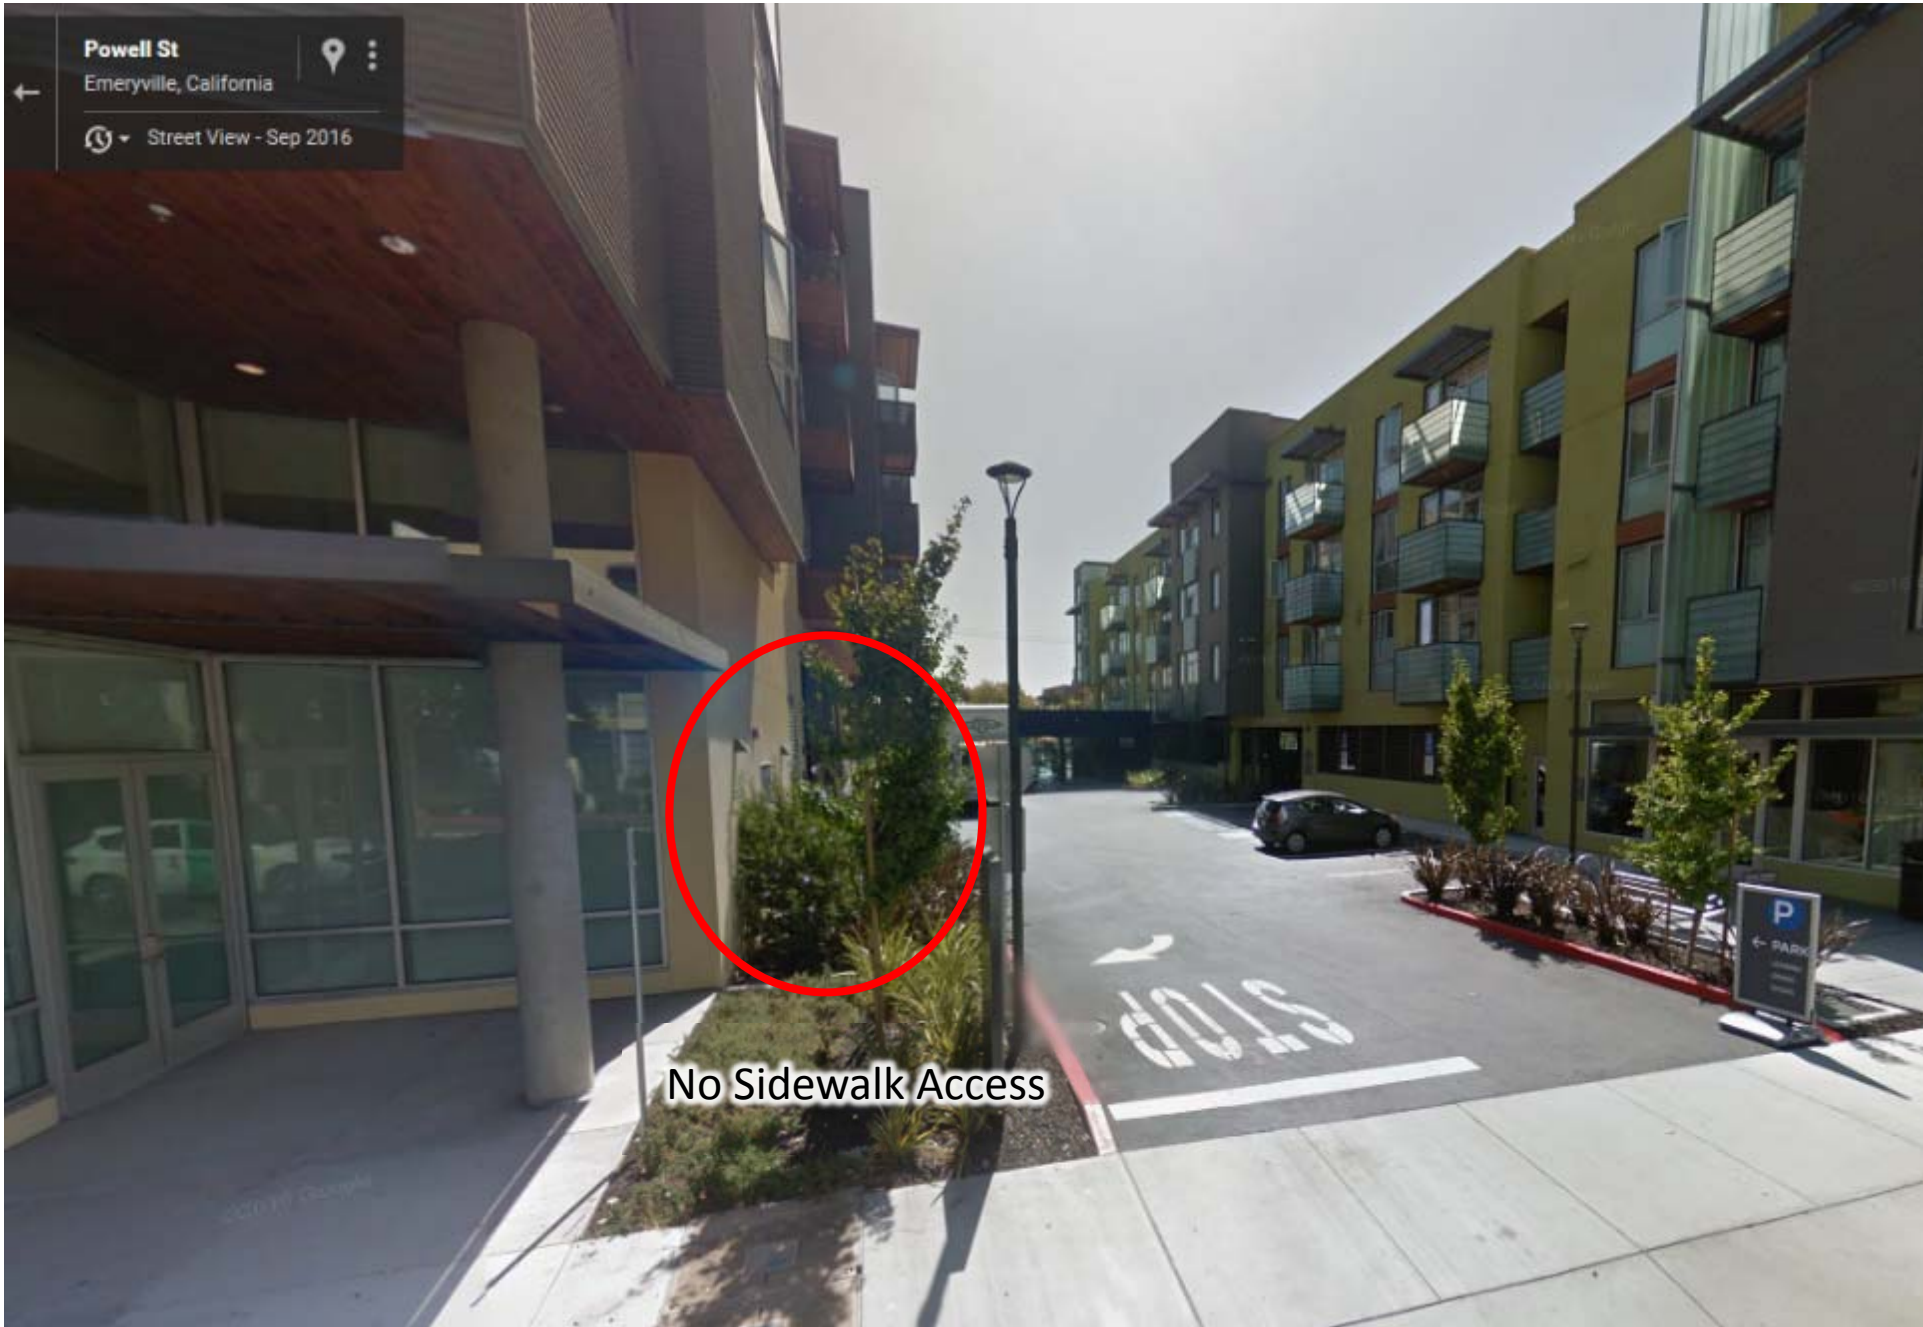
Problems with a Stormwater Control Measure

No Sidewalk Access

1) Downspout runoff bypasses BMP; Drive aisle runoff ponds in low point in front of BMP; Overflow outlet blocked by curb. BMP needs redesign so that runoff enters treatment area. (2) Oil sheen in BMP#2

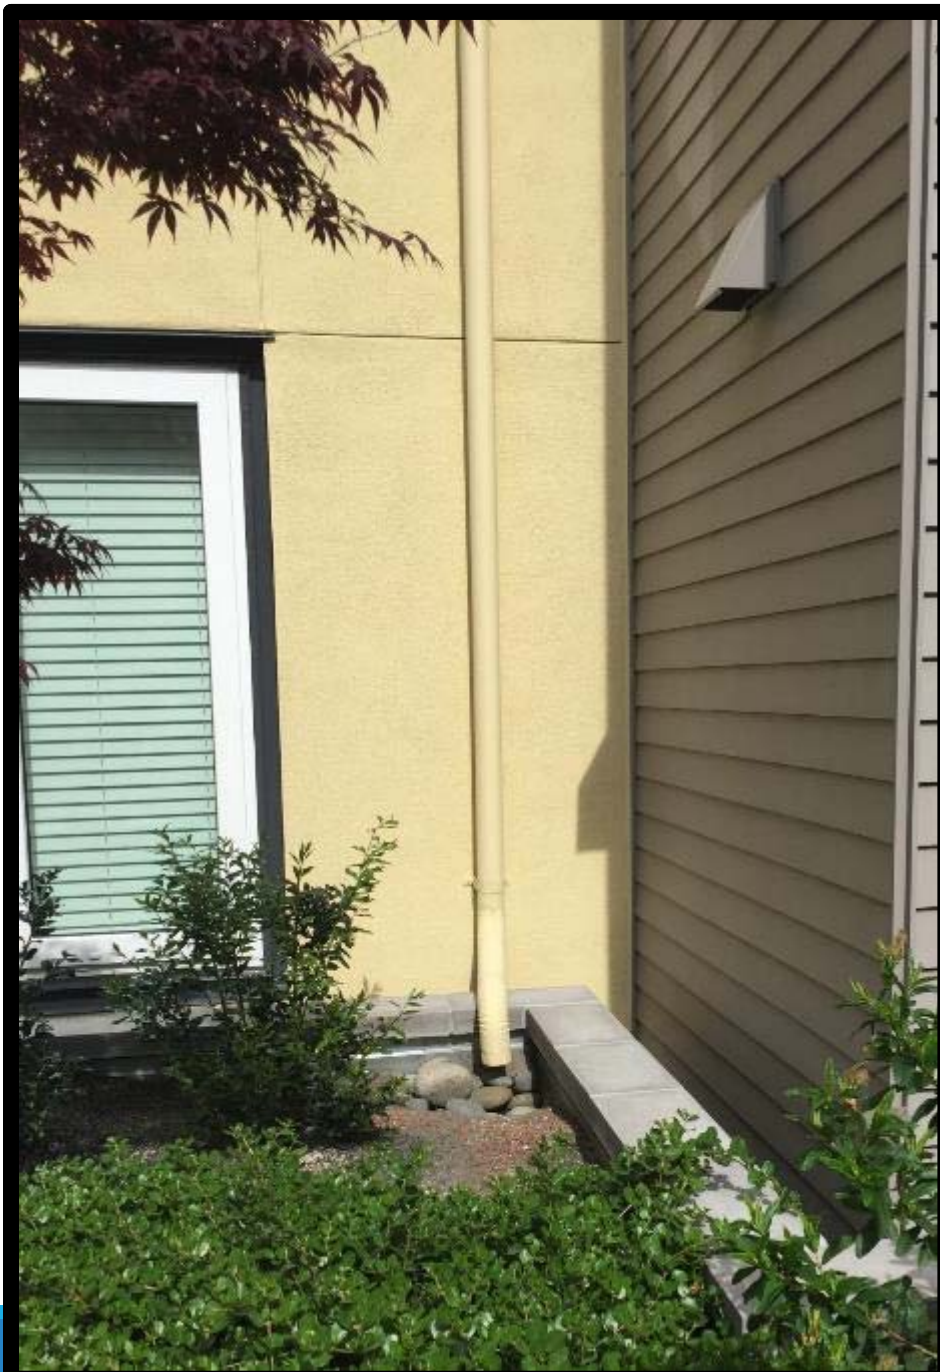
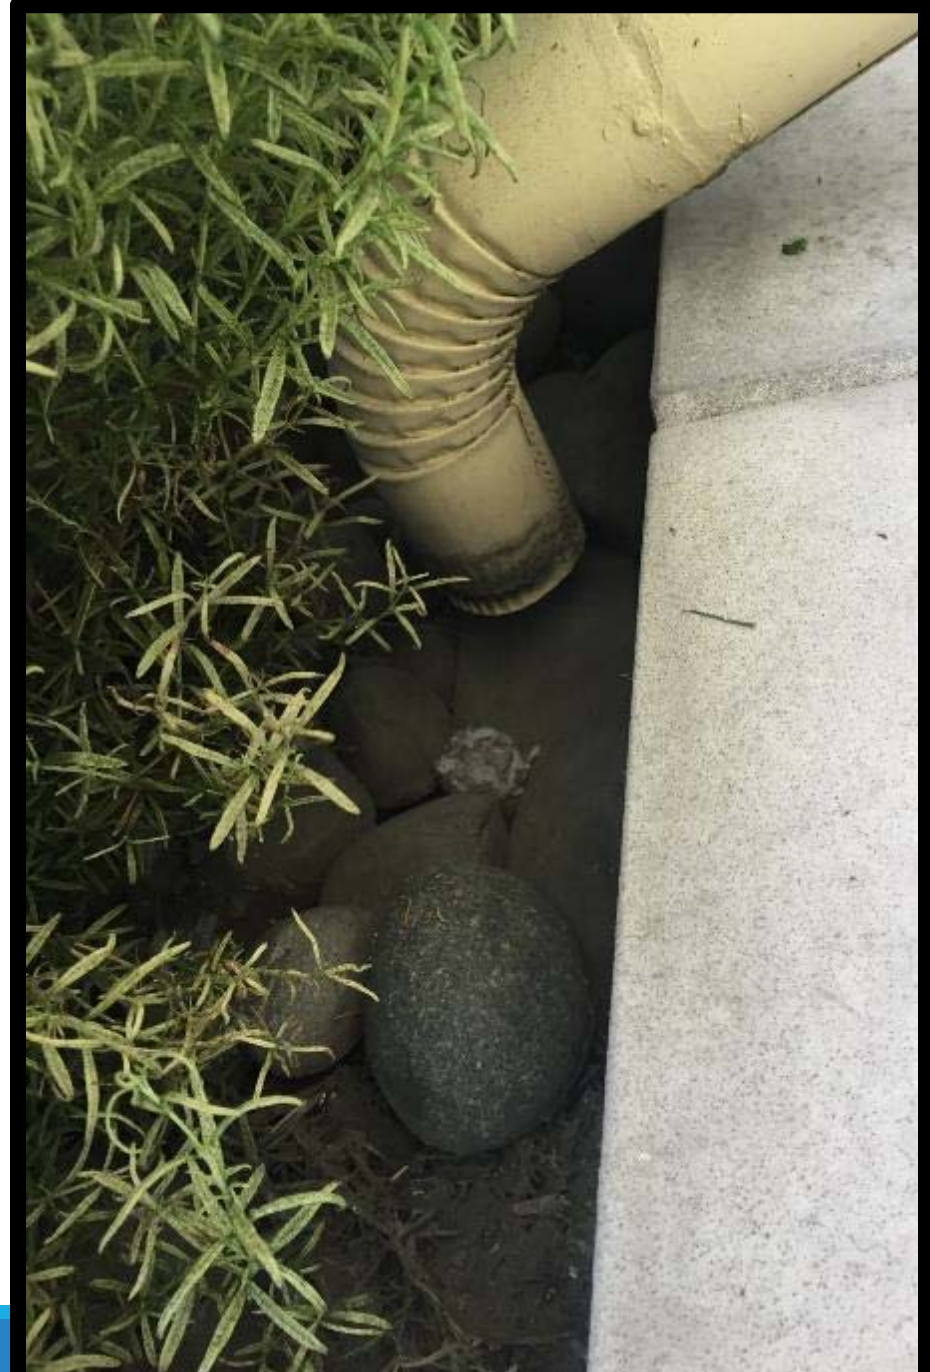
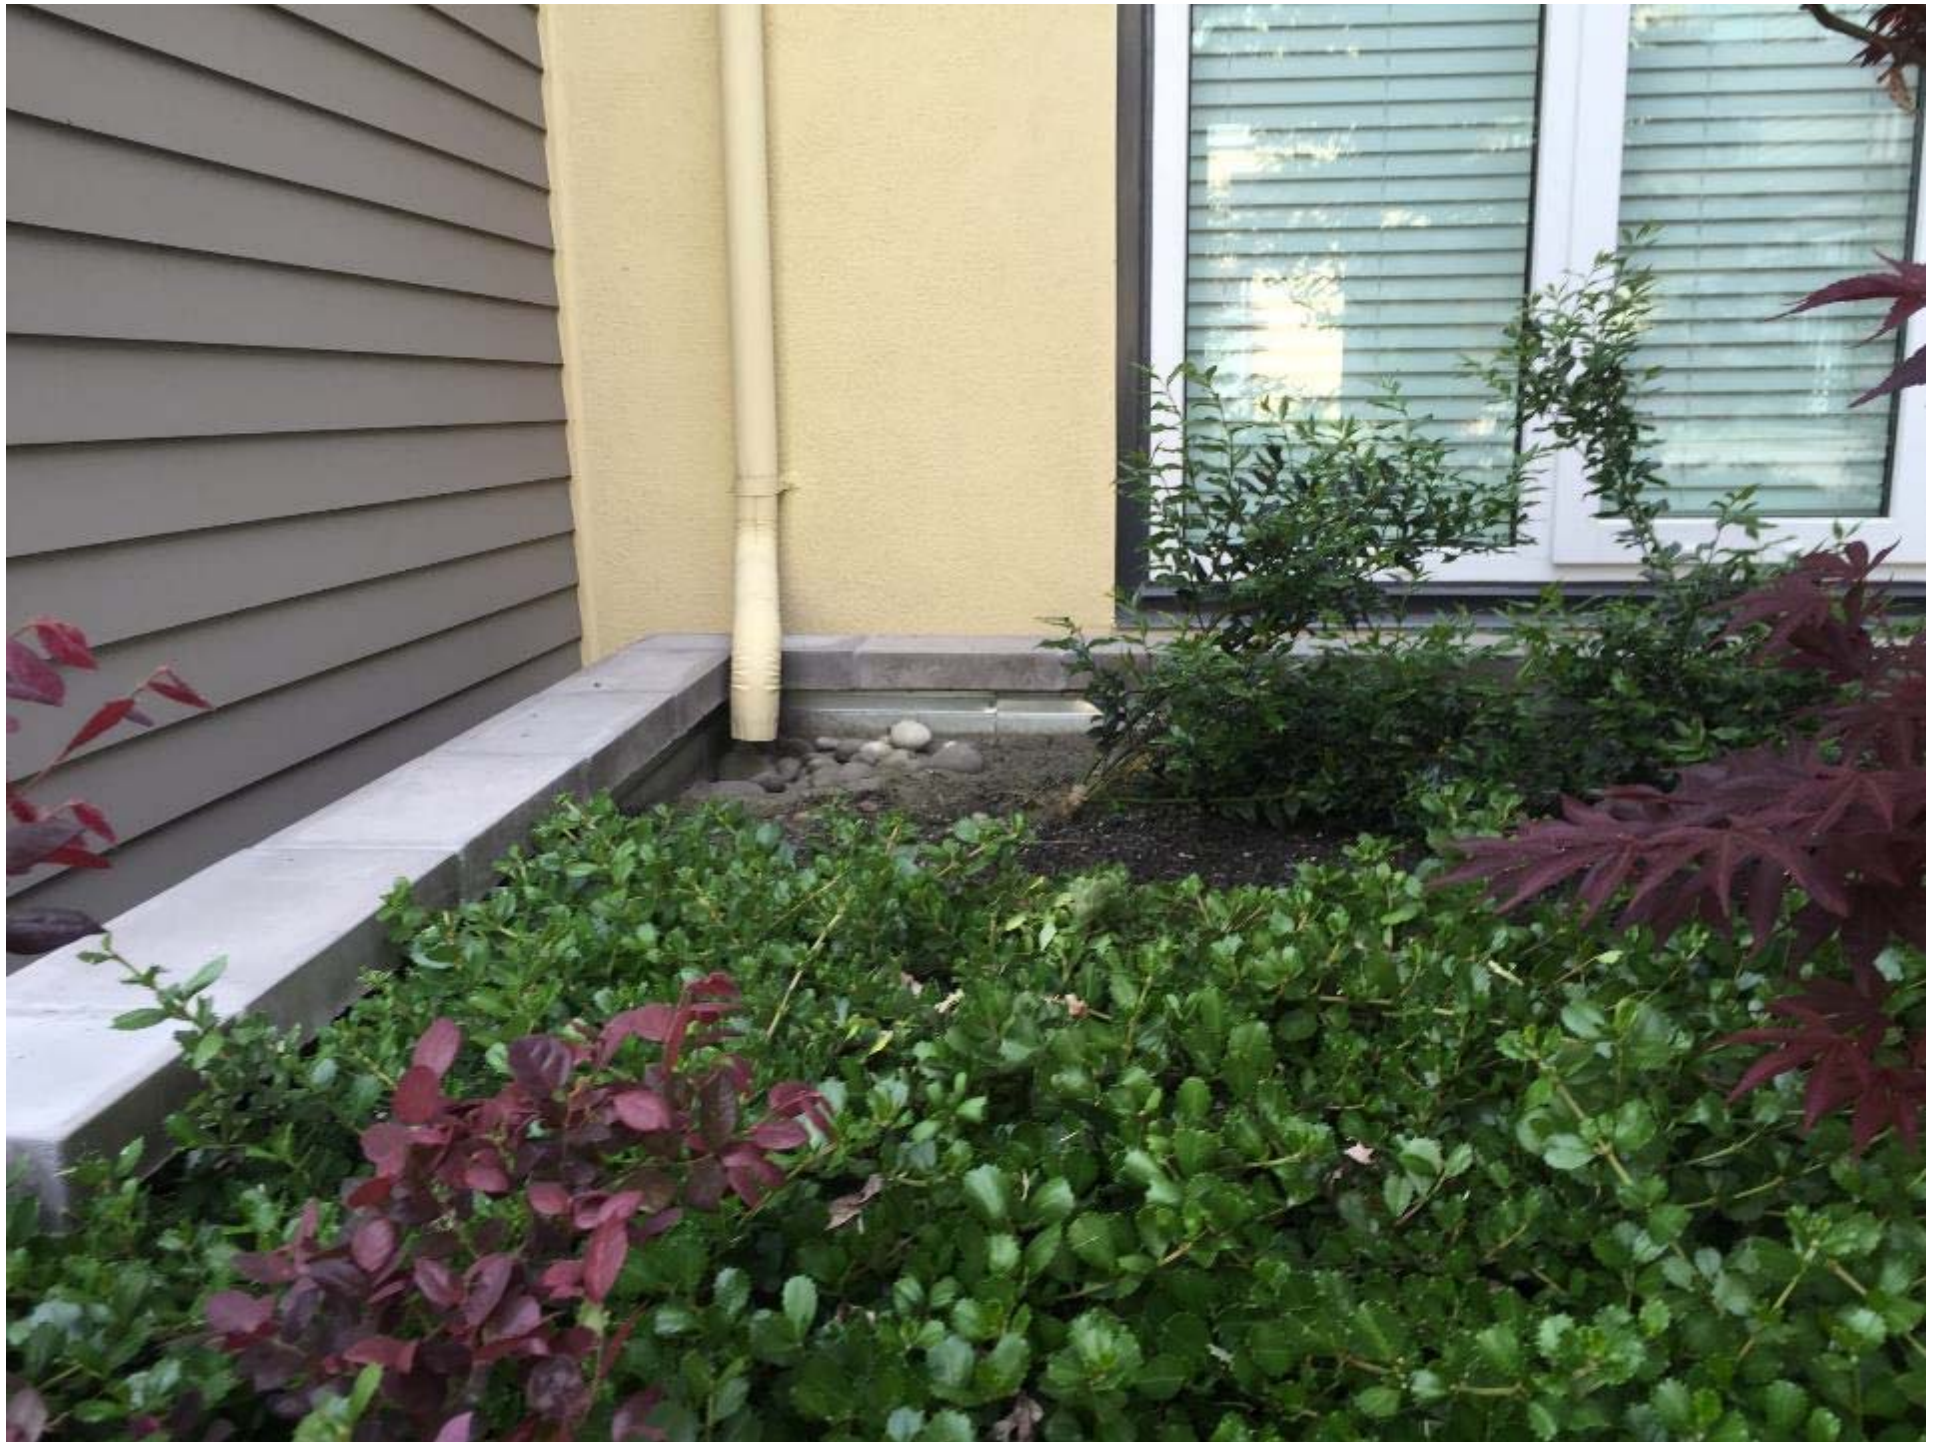
Downspout/Inlet Construction

(1,3)Downspout outlet faces straight down into planter, concentrating flow and causing scour, which can undermine the structure of the box. Discharge should spreading into planter (4) Weeding needed
