CASE SCENARIO: Auto Repair

City of South San Francisco
Environmental Compliance

Auto Repair shop with improvised wash pad

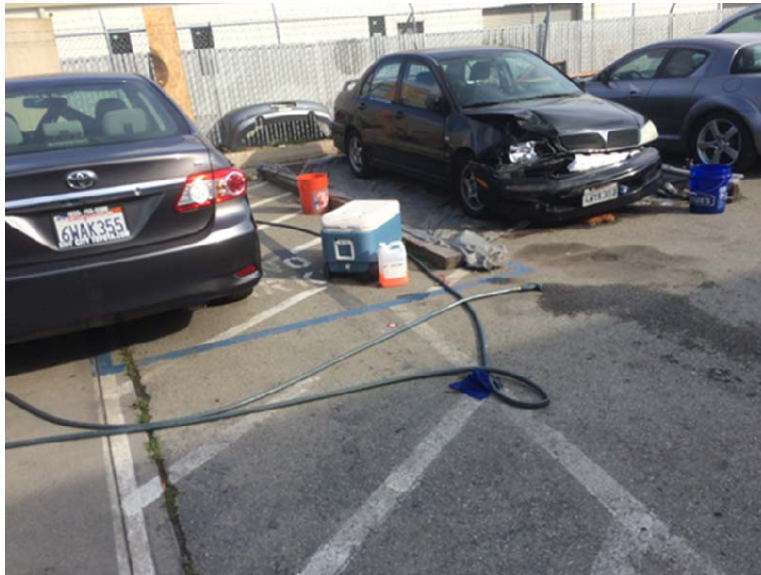
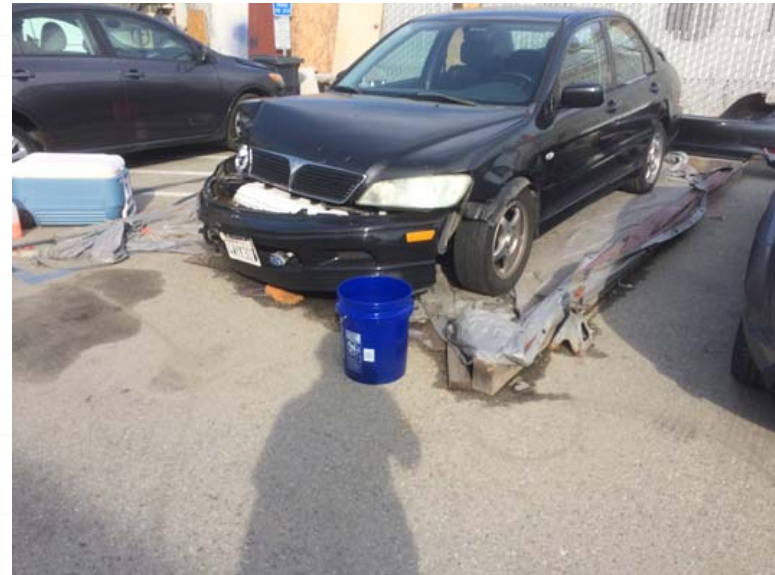
First items noticed:

- Improvised wash pad in disrepair
 - Tarp is in bad condition
 - No containment on front of pad
- Hose and water marks on ground indicating washing occurred with inadequate BMPs in place

Enforcement:

- Cease discharge of water
- NOV issued requiring:
 - All wash waters must not be discharged to storm sewer system.
 - Wash pad must be repaired or replaced and all BMPs must be implemented to prevent wash waters from entering storm sewer system. Wash pad must be adequate to handle any washing that takes place on site. 30 days given for repair.
- Administrative citation of \$500.00 issued

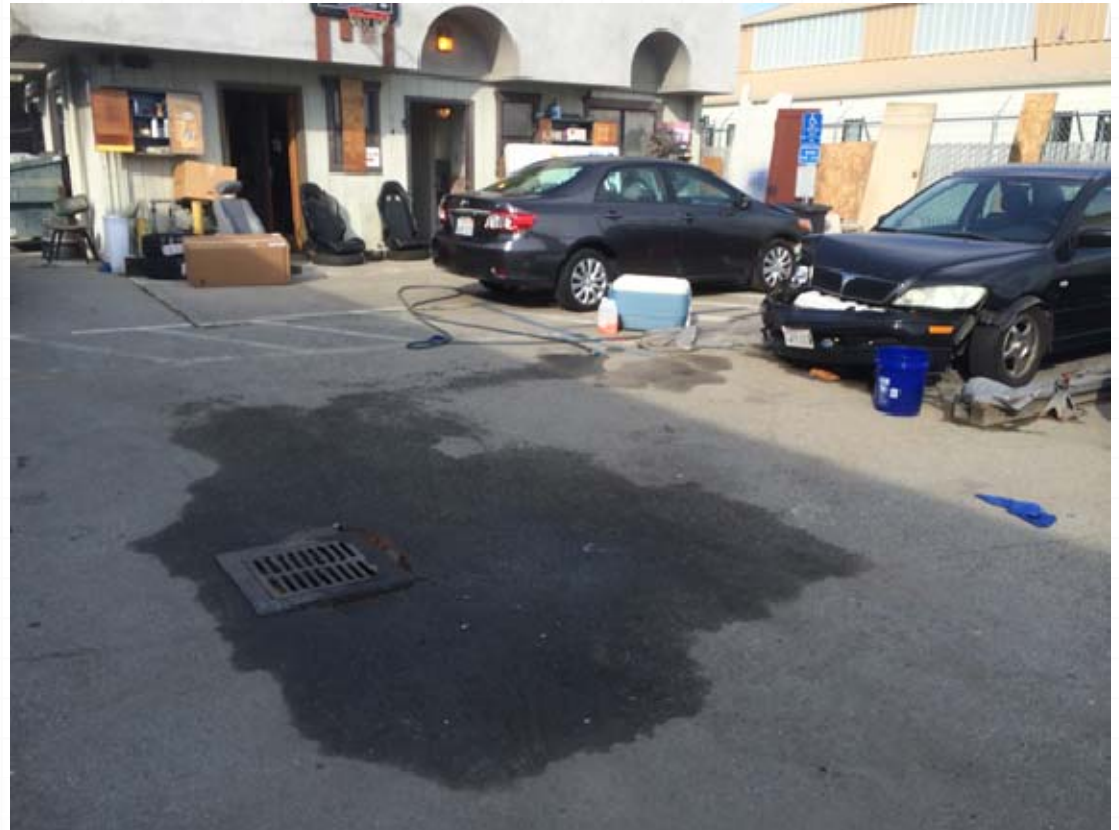
Water marks on ground that indicated an illicit discharge has occurred from the wash pad area, traveling into the parking lot storm drain.

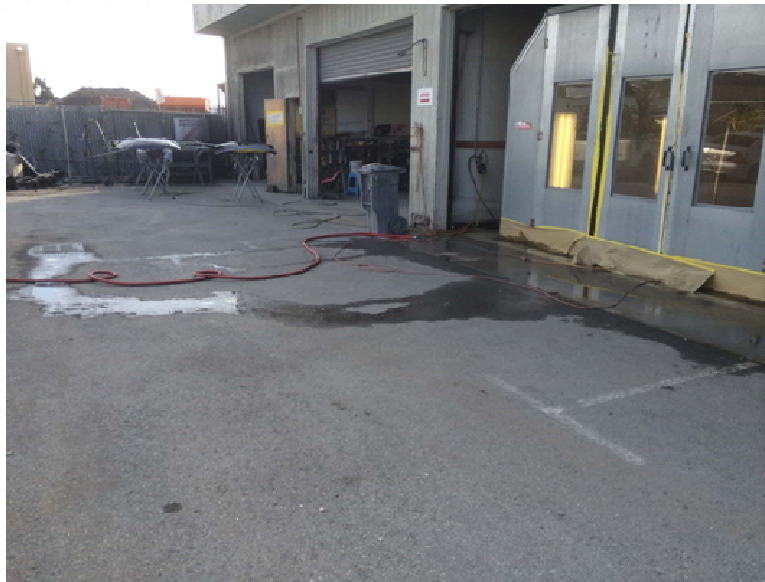
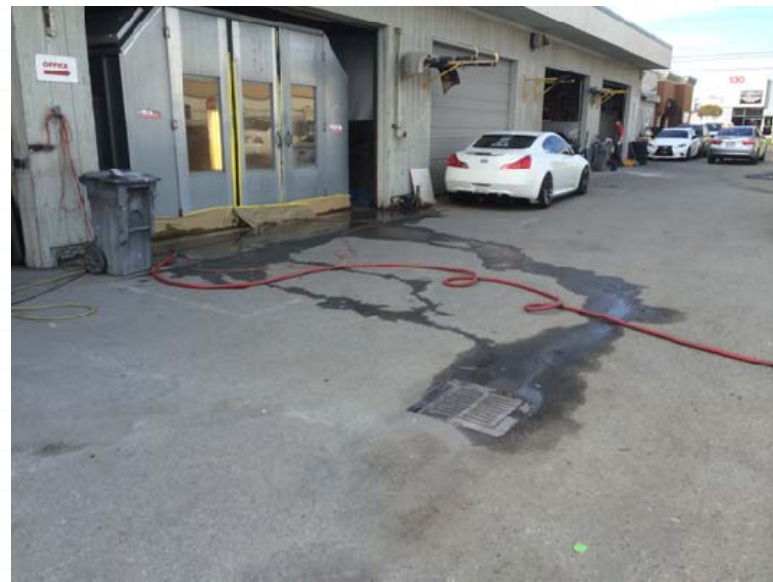
Rear of Auto Repair shop with ongoing discharge

- Waters travelling from a paint booth with no BMPs
- Wet sanding and hosing down paint booth area most likely cause of discharge
- Water noticeably flowing to stormdrain on back on property

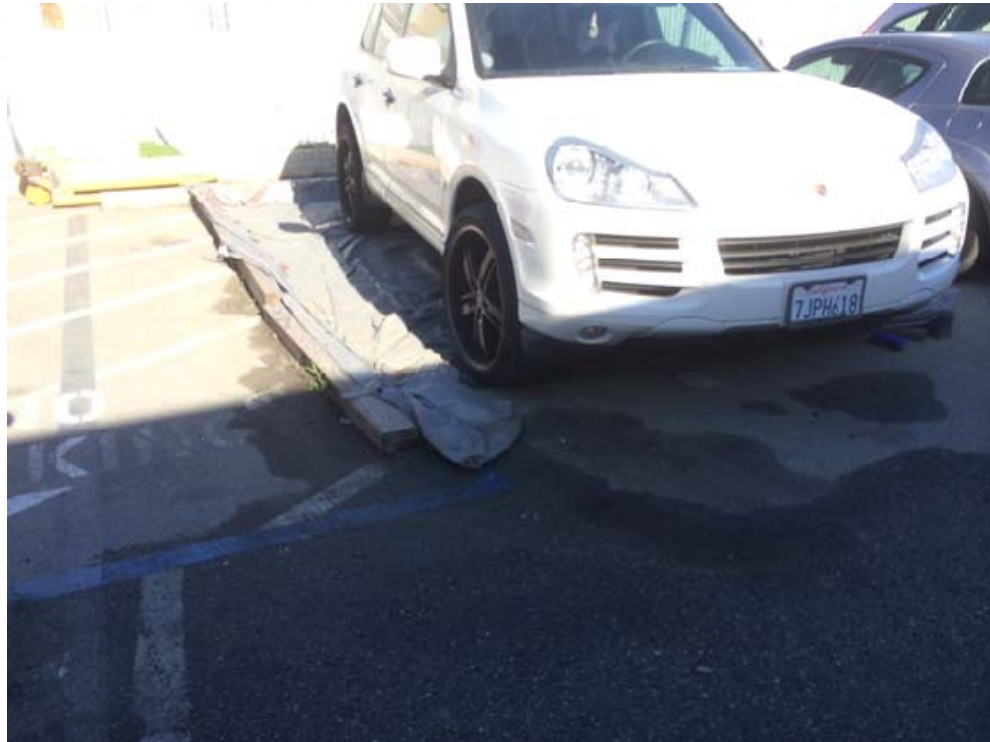
Follow Up

- Improvised wash pad still in disrepair
- Evidence of another illicit discharge coming from wash pad and flowing into storm drain

Enforcement:

- Cease discharge of water
- NOV issued requiring:
 - All wash waters must not be discharged to storm sewer system.
 - Wash pad must be repaired or replaced and all BMPs must be implemented to prevent wash waters from entering storm sewer system. Wash pad must be adequate to handle any washing that takes place on site. Additional 30 days given for repair.
 - BMPs must be used to prevent wash waters from exiting paint booth and entering the stormdrain system.
- Additional administrative citation of \$500.00 issued

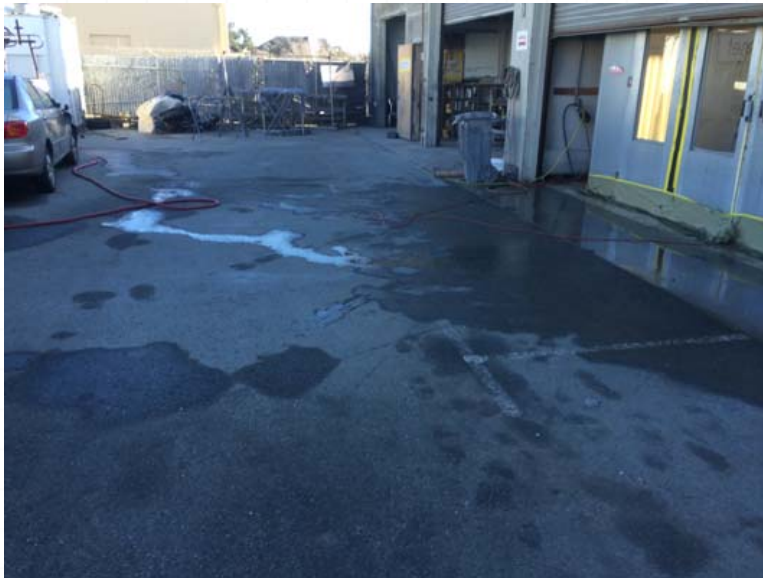
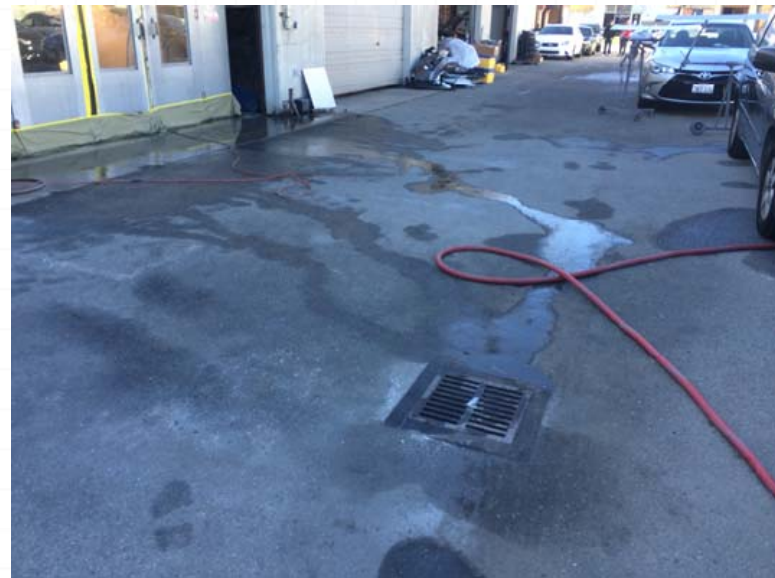
Rear of auto repair

- Illicit Discharge occurring again from paint booth
- White power indicating possible wet sanding on ground, contaminants going to stormdrain
- Additional evidence of water from rear corner of property, indicating possible wash down of parts or vehicle

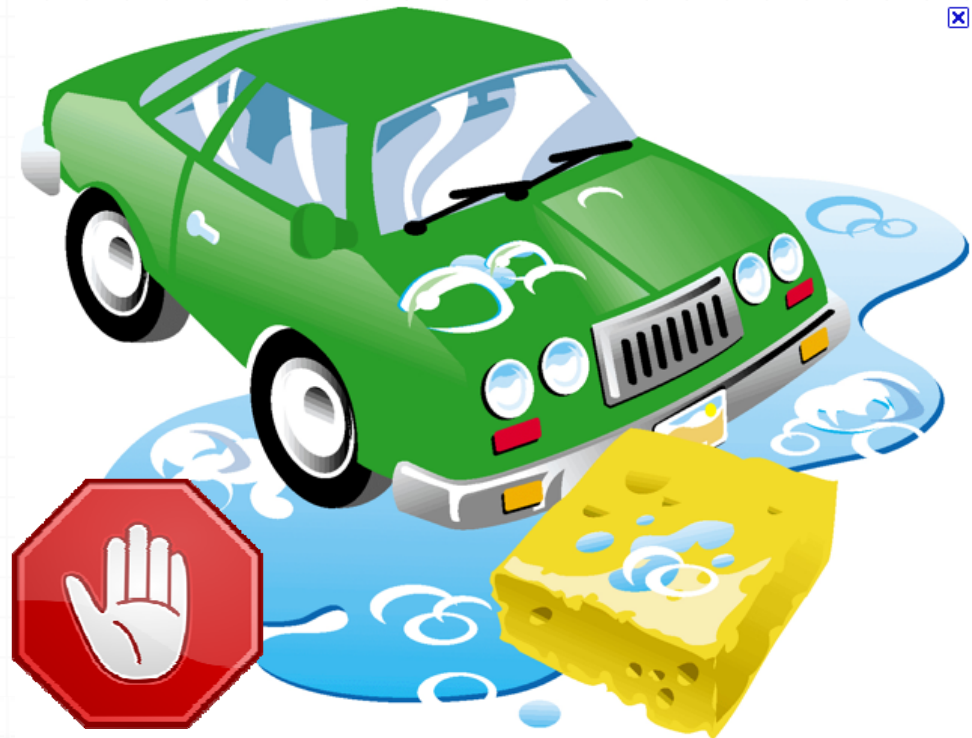
Second Follow Up Inspection

- Improvised wash pad has been slightly improved
 - New tarp added
 - Front of wash pad is slightly raised with board across to keep waters in
 - Upon inspection no real evidence of wash waters entering stormdrain from pad

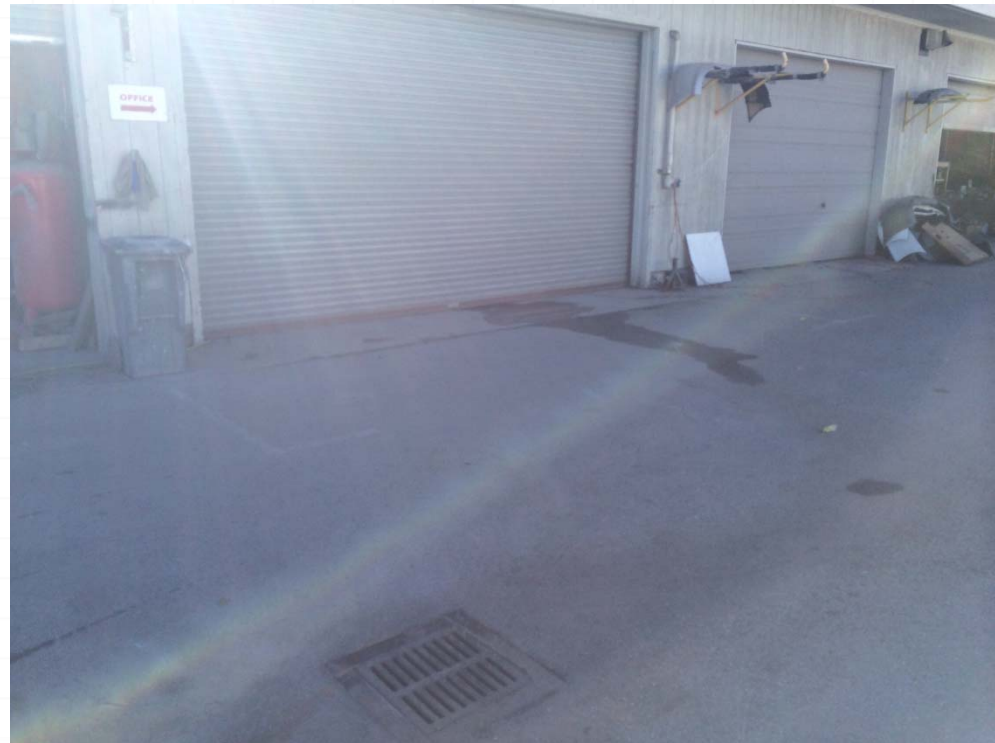
Water stain in rear of facility, but has not reached stormdrain. No flow seen when on site, in this case water will evaporate before reaching stormdrain as is.

- This case study is still on ongoing problematic facility.
- Increased monitoring of facility has been implemented. Administrative citations will be issued if non-stormwater discharges occur.
- Contacting facility owner or property owner will occur to try to bring facility into ongoing compliance. Additionally, they will be informed to keep their dumpster lids closed.
- Will recommend or require, if needed, be a higher berm around improvised wash pad or plugs for stormdrains on property.
