Food Establishment Case Scenario

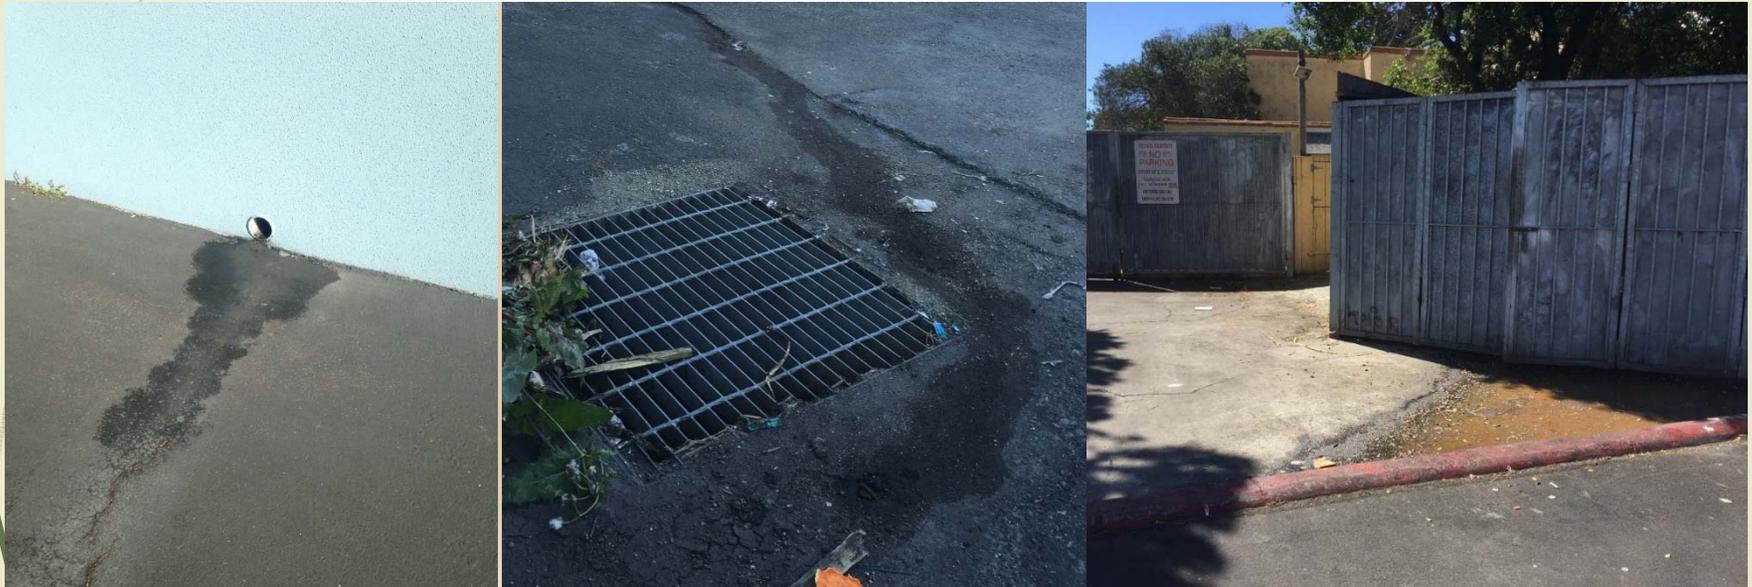
Complaint of a bad smell comes in from a resident walking a trail along side a creek. Next to the creek is a food service establishment and grocery store which sells live fish. Perimeter inspection of the building shows roof drain discharge with an oily discharge on one side of the building. In the back is a storm drain with an ammonia smell. On the other side of the building is a trash enclosure with brown odororous liquid pooled behind a berm with no drain or outlet.

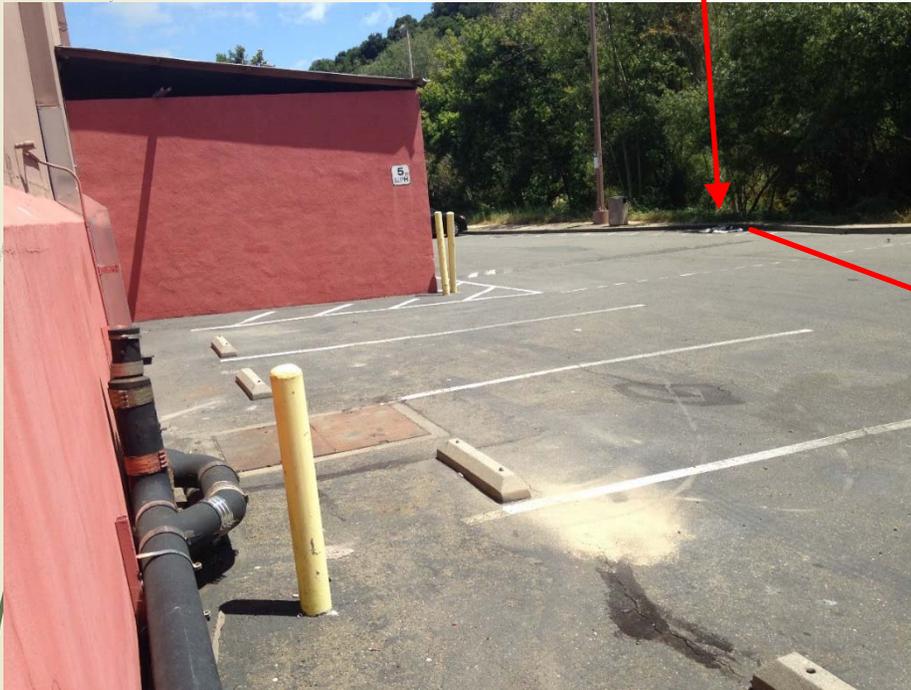
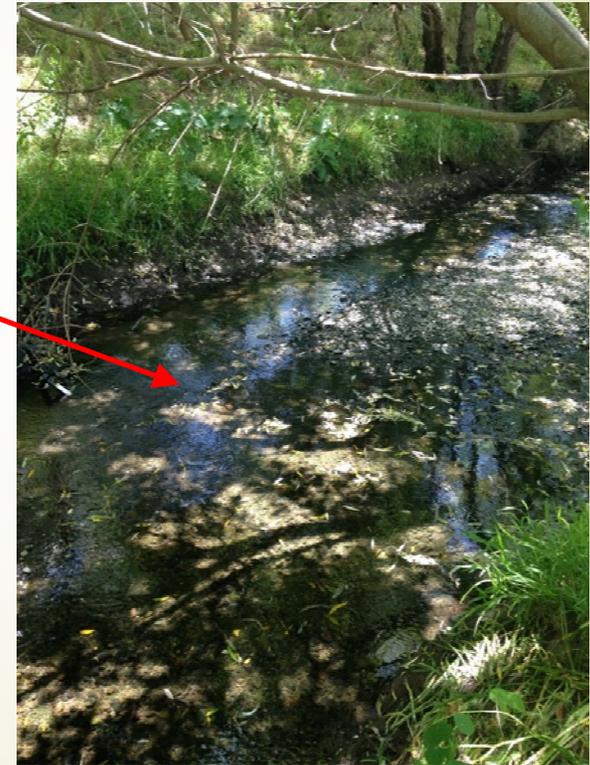
The storm drain discharges directly in to the creek.

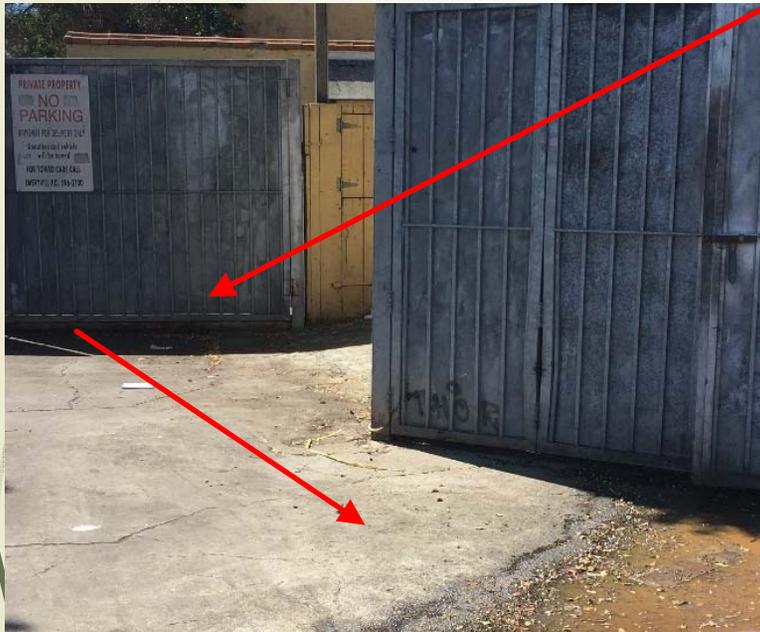
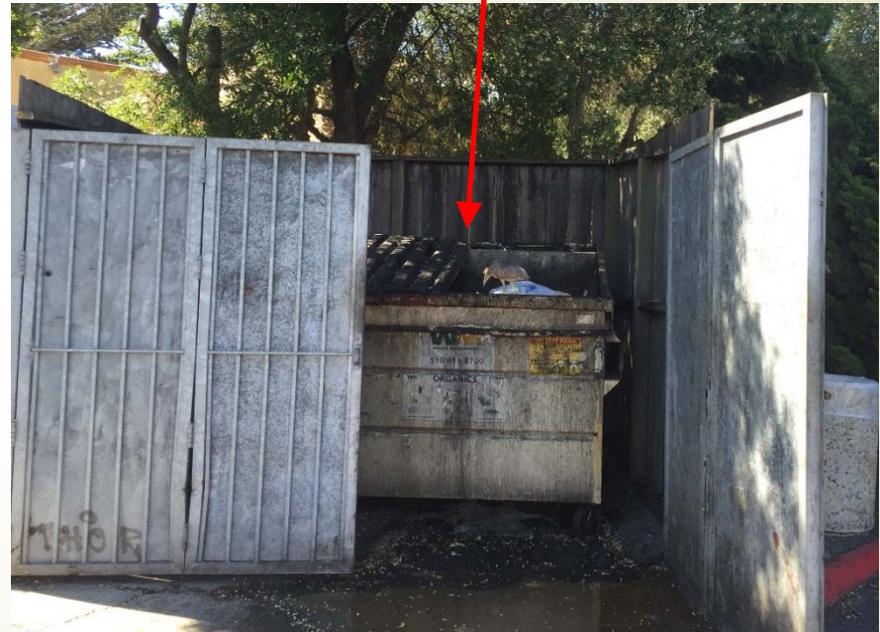
Closer inspection of the trash enclosure shows pooled water in front of trash bin with exposed garbage. Yet stain trail starts at an outlet up by the gated area. Also noticed animals foraging out of open trash bin

- ▶ Restaurant management able to confirm clogged drain behind gate is connected to a sanitary sewer
- ▶ Referral made to sanitary pretreatment program
 - ▶ Most likely will require cover over outside sanitary drains
 - ▶ May require treatment and self monitoring of discharge
- ▶ Brown stain and pooled water from grinding meet outside and washing down equipment and scraps which plugged the drain and discharged through overflow
- ▶ Corrective actions:
 - ▶ Required to immediately vacuum and clean up area behind the berm
 - ▶ Keep trash lid closed
 - ▶ Ensure drains are clear, keep water from reaching overflow
 - ▶ Keep trash enclosure, grease bin area, and other outside areas clean at all times, immediately vacuum any overflow
 - ▶ Wash mats and food processing equipment in dish washer or utility sink
 - ▶ Train employees in best management practices

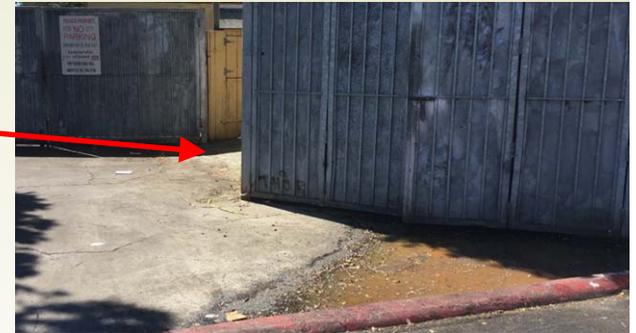
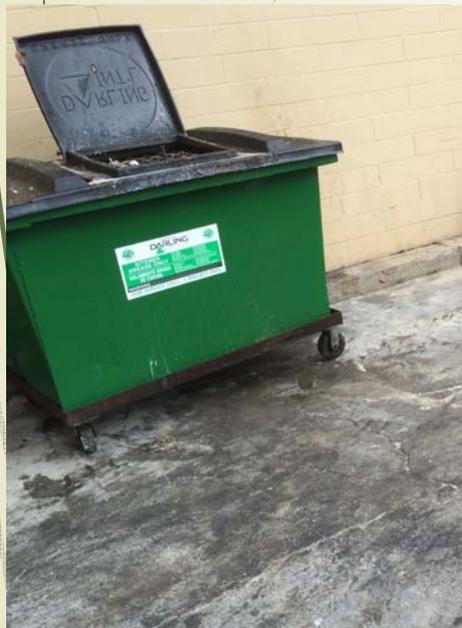
Behind the gate is an outside storage area with a similar brown stain leading to a drain with clogged drain and overflow which appears to discharge to the other side of the gate.

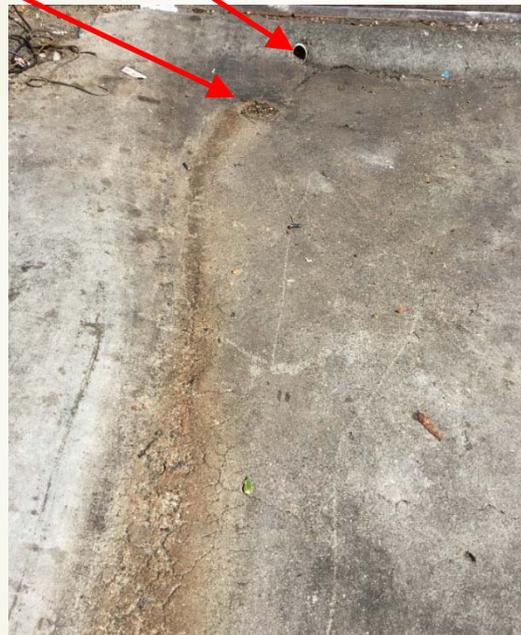
On one side of the stain is a grease bin with black stain not visibly connected to the brown stain

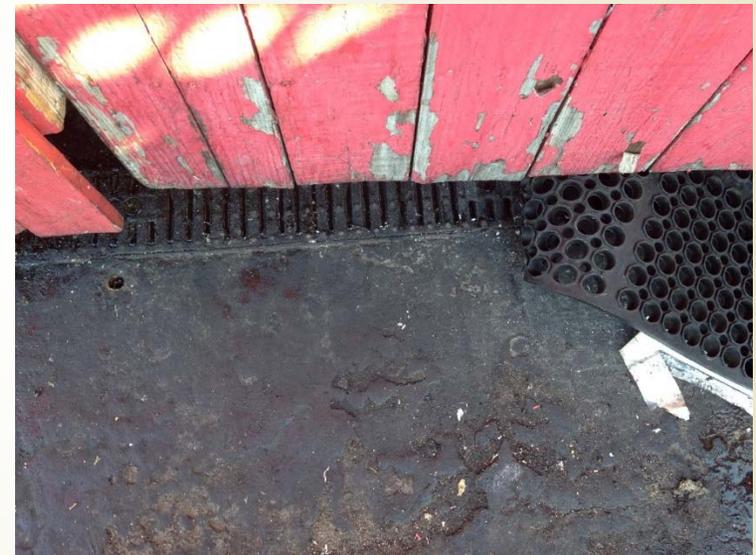
Brown stain leading to drain

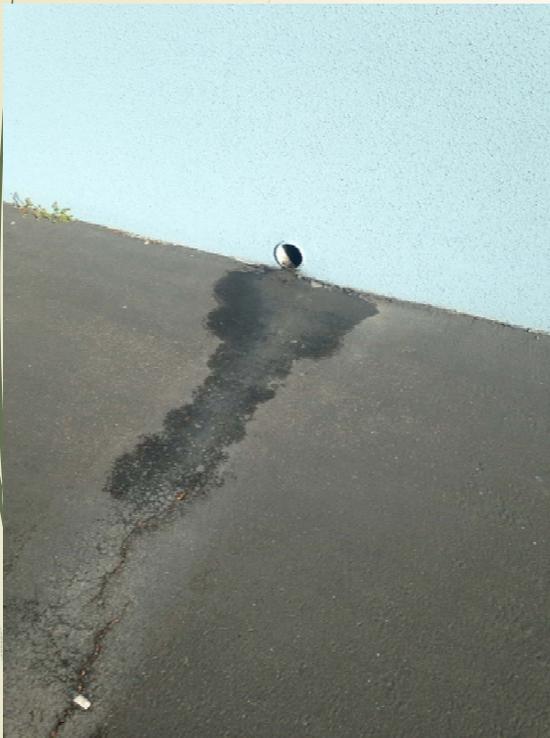
Roof Top Drainage

- ▶ Oily residue discharge and stain did not reach the storm drain
- ▶ Building management notified to take the following corrective actions
 - ▶ Check roof top equipment for oily leaks
 - ▶ Repair leaky equipment
 - ▶ Place absorbent socks around constant discharges such as equipment blowdown
 - ▶ Clean-up any oily residue on roof and pavement with the stain
 - ▶ use power steamer
 - ▶ vacuum up dispose of wash water properly

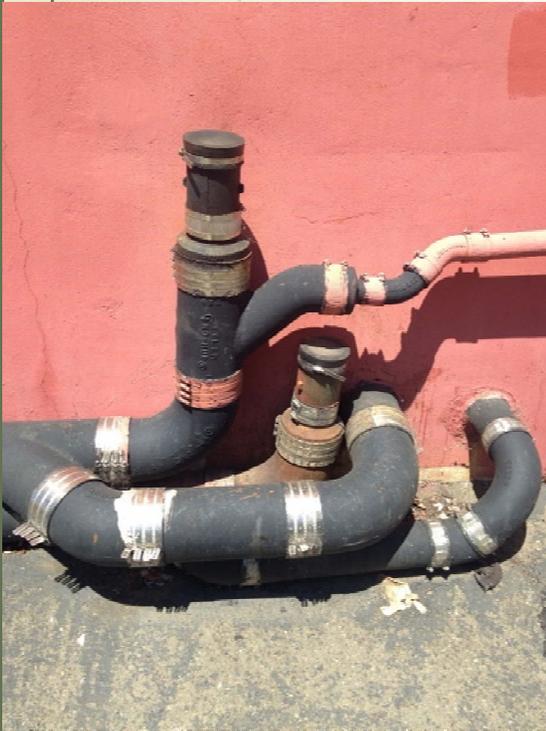
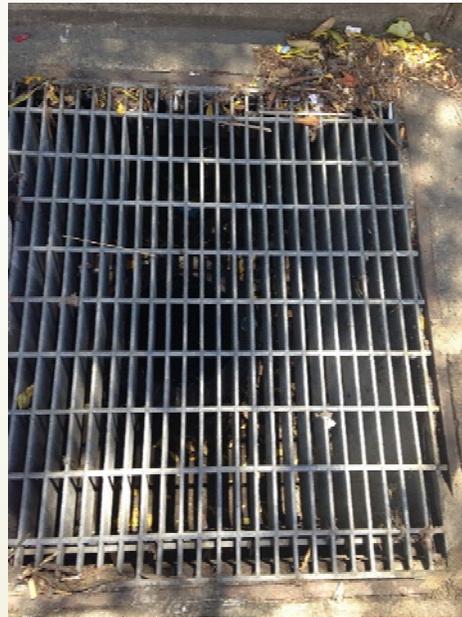
Line from fish cleaning area in the market clogged. When the plumber (mobile business) flushed the line of blocked fish scraps, it overflowed the cleanout. They washed it to the storm drain which flowed into the creek.

- ▶ Issued (2)\$250 Administrative Citations
- ▶ Contacted State Fish and Wildlife
- ▶ Required the Market to place and maintain a finer mesh screen over inside drains to prevent clogging of the line, especially debris from the fish cleaning
- ▶ Required Market to install and maintain storm drain insert in the drain inlet
- ▶ Required staff training
- ▶ Required Market management to be present when a plumbing contractor cleans the lines
