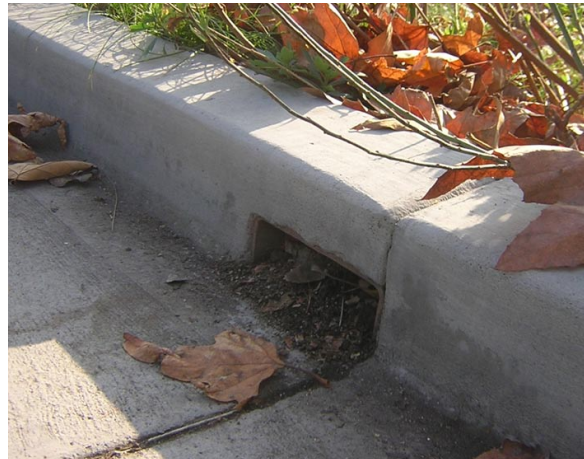
Figure 5-29: Bad example - a notched curb cut is way too small and constantly overloaded with sediment.

Curb cuts along stormwater facilities should be as wide as possible to accept flow from along the street or parking lot edge. A flaw in curb cut design is to try to “cover” or create a notched curb cut. These designs often fail because the opening for stormwater runoff is restricted and results in trapped sediment and debris. When a notched curb cut is plugged with debris, it often goes unnoticed. It is recommended that an 18 inch minimum width “open” curb cut be used at entrances to stormwater facilities. On steeper streets, it is a good idea to build a small, low-profile asphalt or concrete berm at each curb cut inlet to guide stormwater flow into the stormwater facility. Without such a measure, runoff can sometimes flow past the curb cut and bypass the stormwater facility during intense storm events. Grated curb cuts are often used in street applications to allow water to flow underneath sidewalks. Grated curb cuts for green streets need special design attention and maintenance to assure water will flow into the stormwater facility. Also, grates need to be slip resistant and American Disability Act (ADA) compliant.

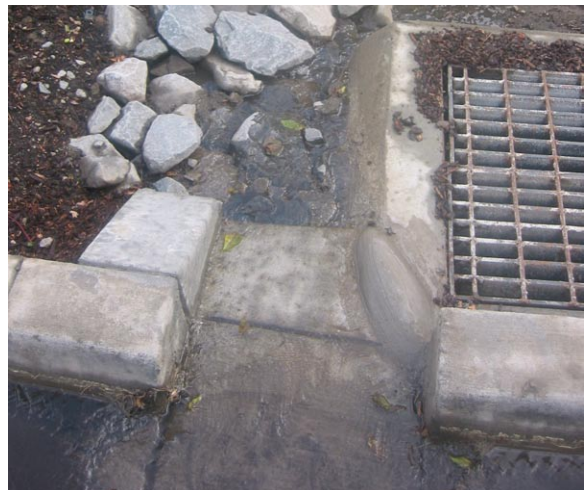
Figure 5-30: Bad example - a curb cut placed immediately adjacent to the overflow inlet.

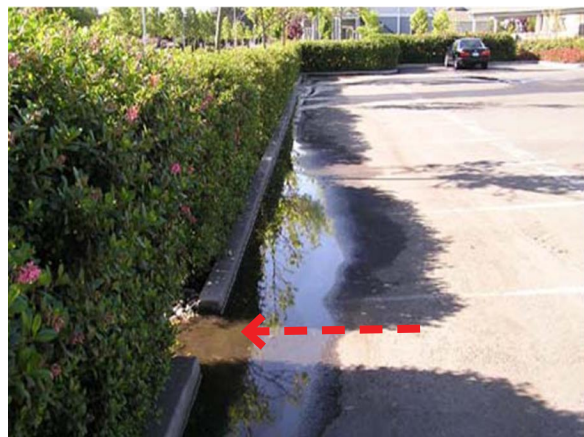
Figure 5-31: Bad example - a curb cut blocked by sediment prevents water flow into this stormwater facility. There is not enough grade change between the curb cut entry and the finish grade of landscaping.

Both sheet flow and curb cut systems need to allow for a minimum 2 inch drop in grade between the street/parking lot grade and the finish grade of the stormwater facility. This drop in grade assures that water will freely enter the landscape space even if there is some sediment accumulation.
