4.6 Green Roof

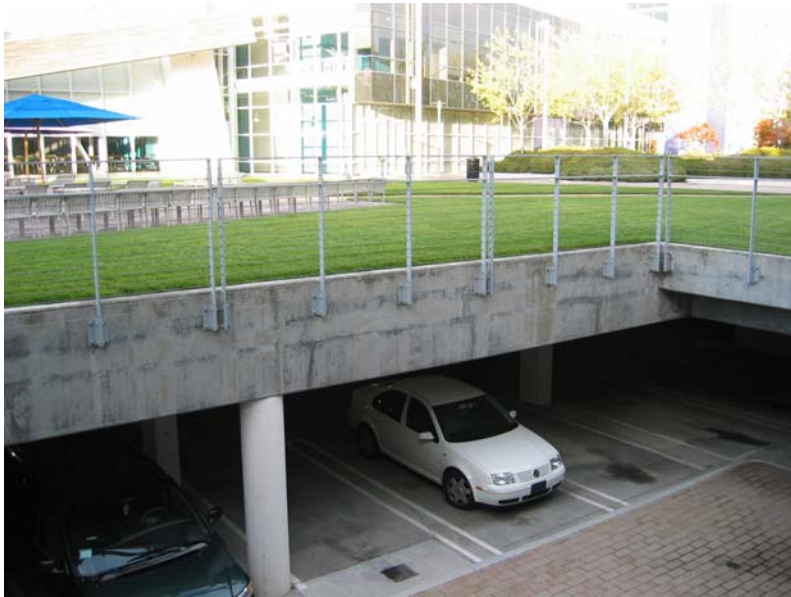
Figure 4-8: Parking Lot with Turf-Covered Roof, Google building, Mountain View

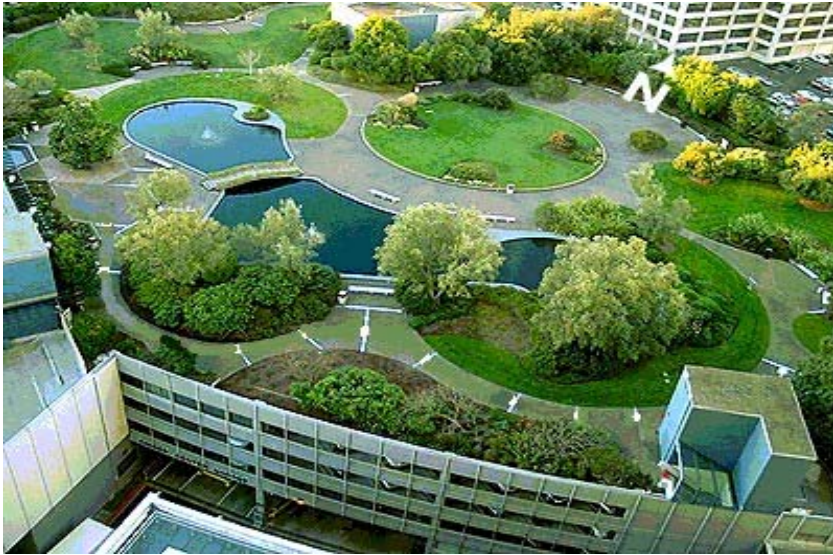
Figure4-9: Intensive Green Roof at Kaiser Center Parking Garage, Oakland.

A Green roof can be either *extensive*, with a 3"-7" lightweight substrate and a few types of low-profile, low-maintenance plants, or *intensive* with a thicker (8" to 48") substrate, more varied plantings, and a more garden-like appearance. The extensive installation shown in Figure 4-10, at Gap Headquarters in San Bruno, has experienced relatively few problems after nearly a decade in use. Green roofs may be considered “self-treating areas” and may drain directly to the storm drain, as allowed by the municipality.

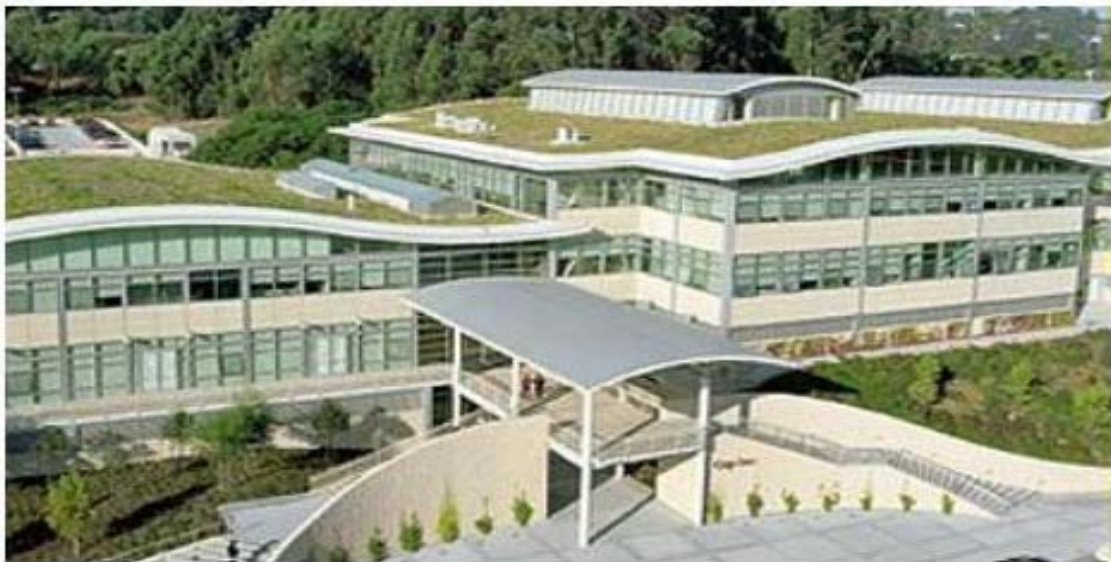
Figure 4-10: Extensive Green Roof at Gap Headquarters, San Bruno (William McDonough & Partners)
