Small and Large Parking Lots

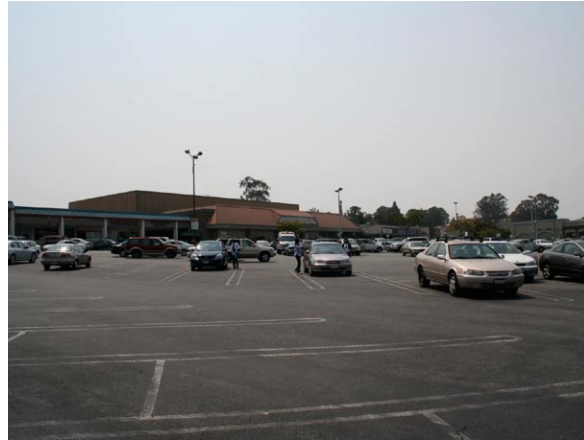
Figure 3-10: A typical parking lot condition in San Mateo County.

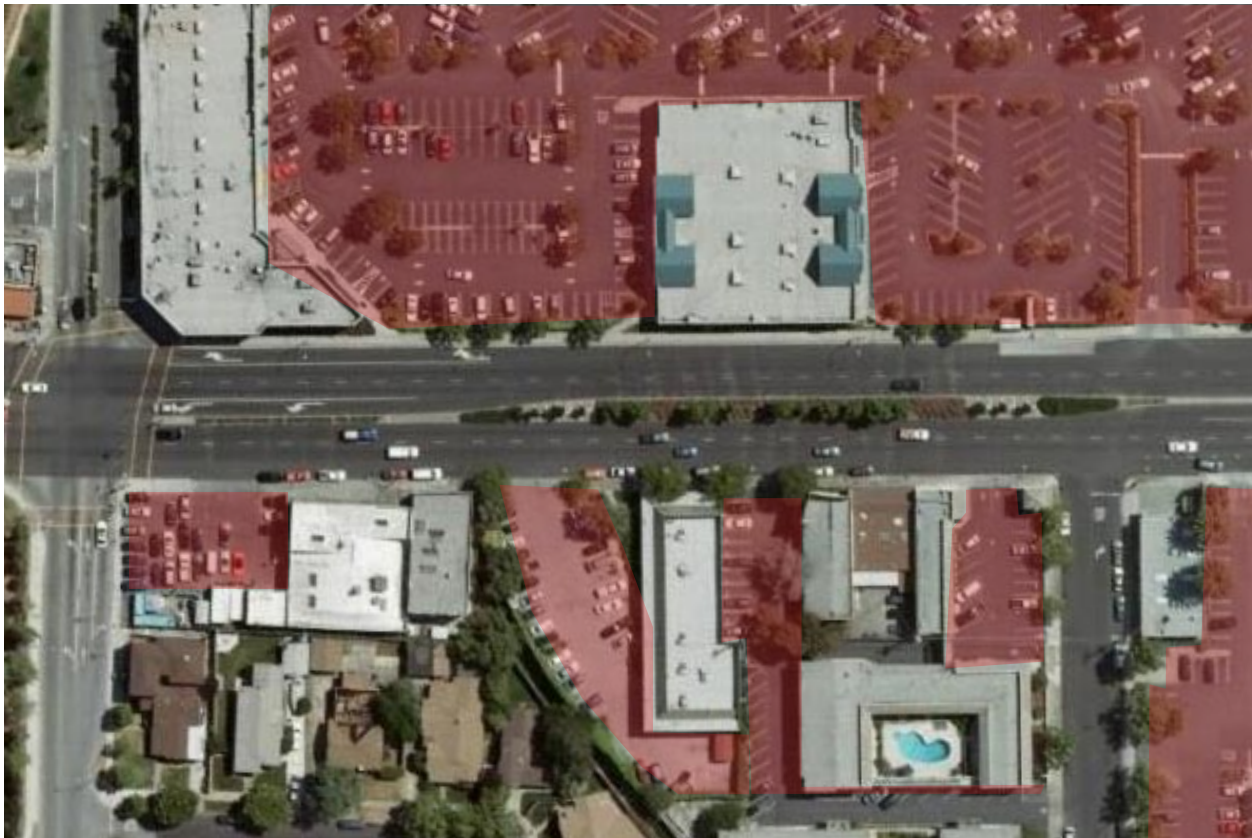
Figure 3-11: The red areas superimposed on this aerial photo illustrate the impervious parking lot area that generates runoff from small and large parking lots.
